## The Mw 7.8 November 14, 2016 Kaikoura Earthquake: Briefing 5.

This fifth briefing contains observations arising from a visit to Wellington and Blenheim (Dec. 5 – 12, 2016)

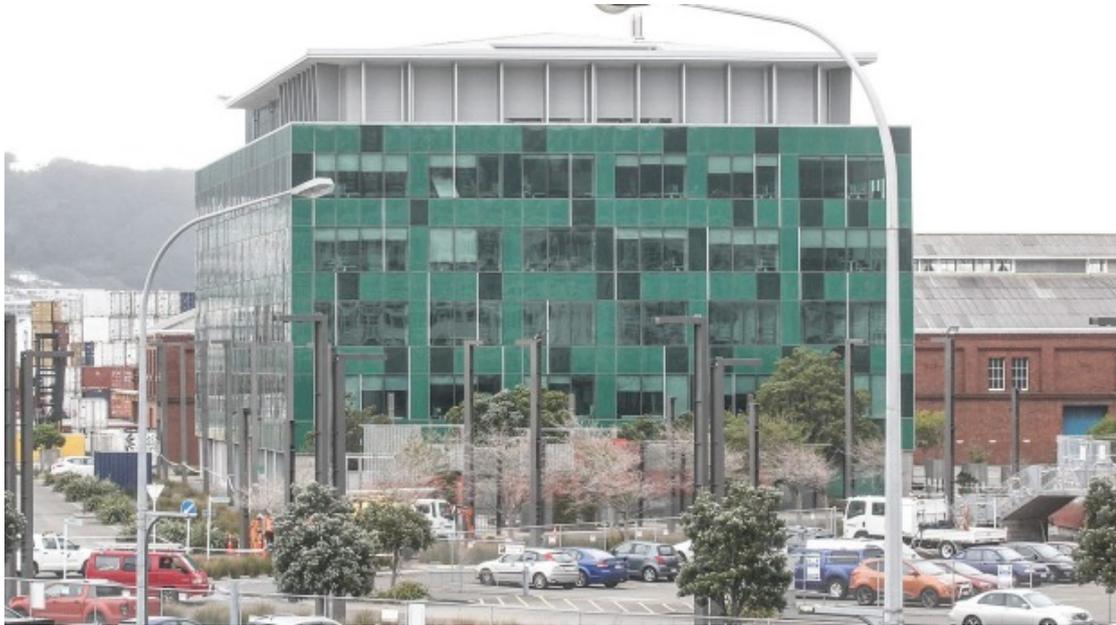
**Statistics House (Figure 2)** -- vulnerability to ground shaking had already been recognised and the top story already retrofitted. In the November 14 event, two lower floors partially collapsed together with a lot of non-structural damage. In Figure 3 collapsed floor planking is visible. Four other buildings owned by CentrePort also suffered damage including Customhouse, Shed 39, the BNZ building that had suffered severe non-structural damage in the Seddon earthquake in 2013, and Shed 35, an unreinforced masonry heritage building.

**Figure 2:** Statistics House – the major structural damage is to the lower left hand corner of the building, and there is nonstructural damage on other floors. (<http://www.stuff.co.nz/national/nz-earthquake/86510017/questions-asked-in-capital-but-engineers-say-no-such-thing-as-earthquakeproof>). Shed 39 is the masonry building to the left and behind Statistics House.

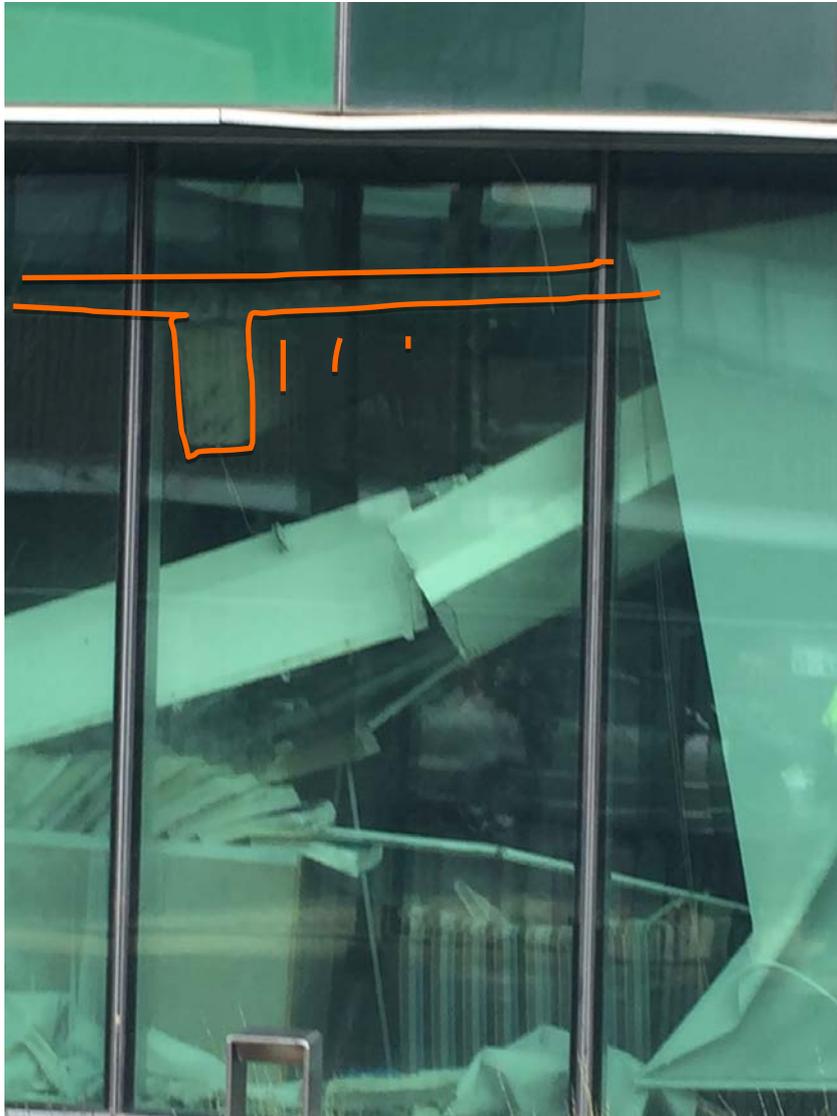
**Figure 3:** Failure of pre-cast floor element in Statistics House, and a lot of non-structural debris.

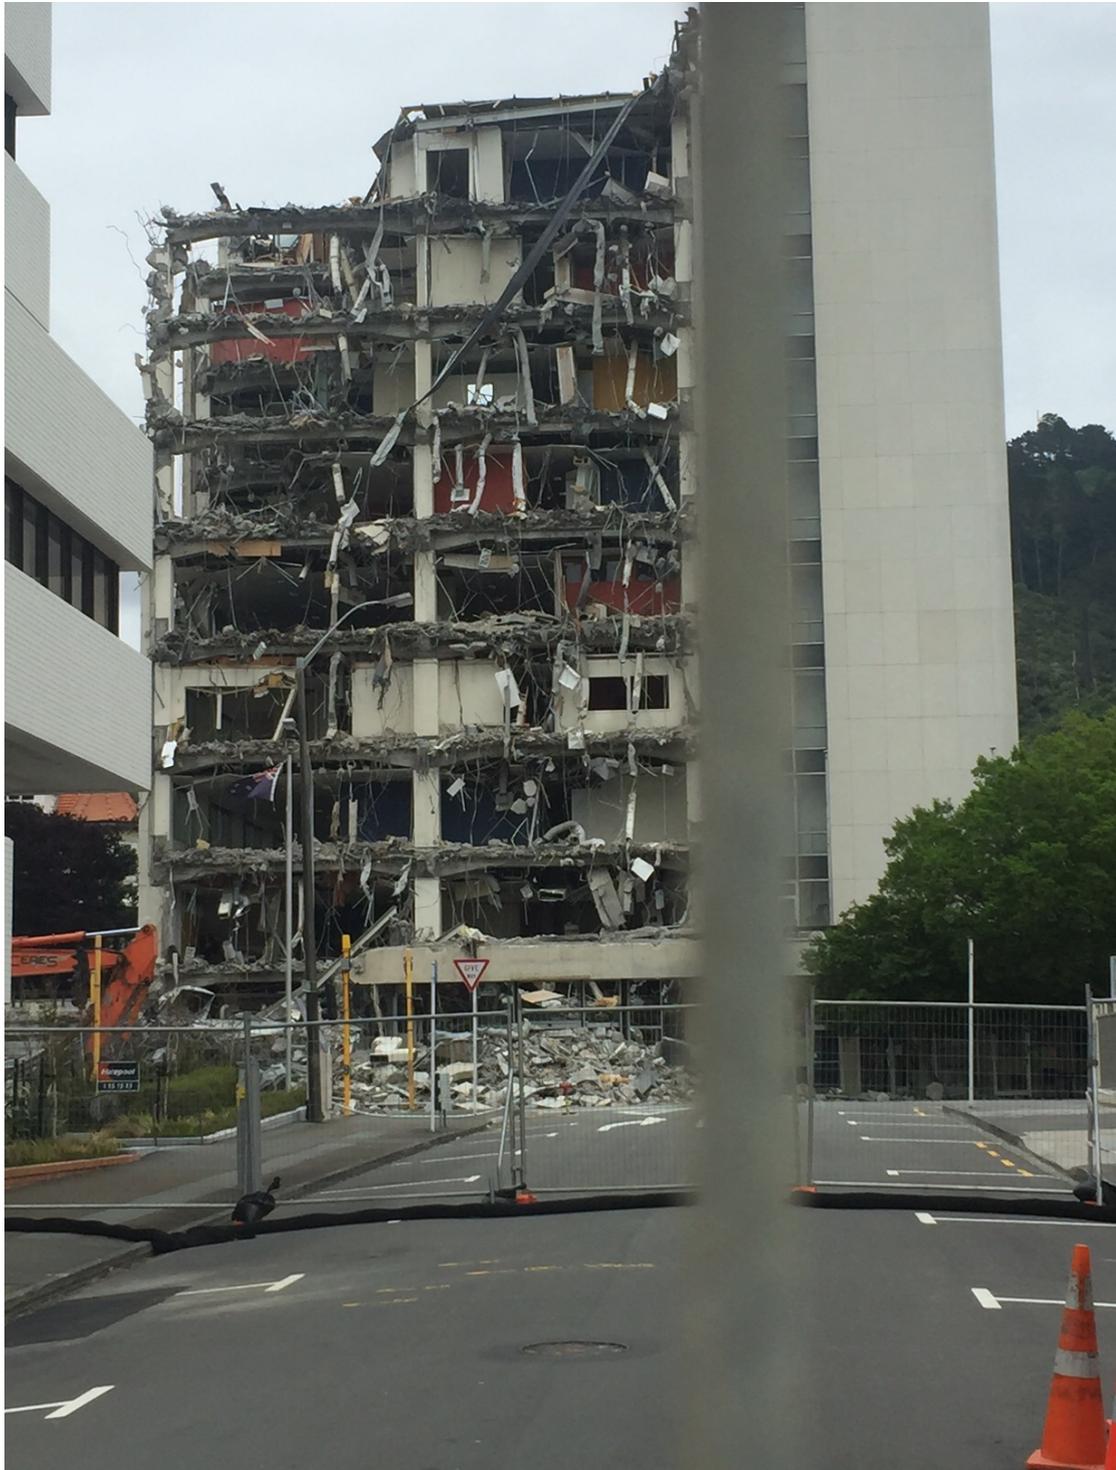
**61 Molesworth Street:** This formerly ‘vacant’ multi-story building (Figure 4) is being demolished already. A column on level 4 sheared and left the curtain wall vulnerable. It’s believed that the owner of the building, Primeproperty, made a commercial decision to take the insurance payout and to demolish presumably with the intention of rebuilding something higher and better. Tenants who were living illegally in the building have not been allowed to retrieve personal belongings because of the risk of failure.

**Figure 4:** 61 Molesworth Street in the process of being demolished.

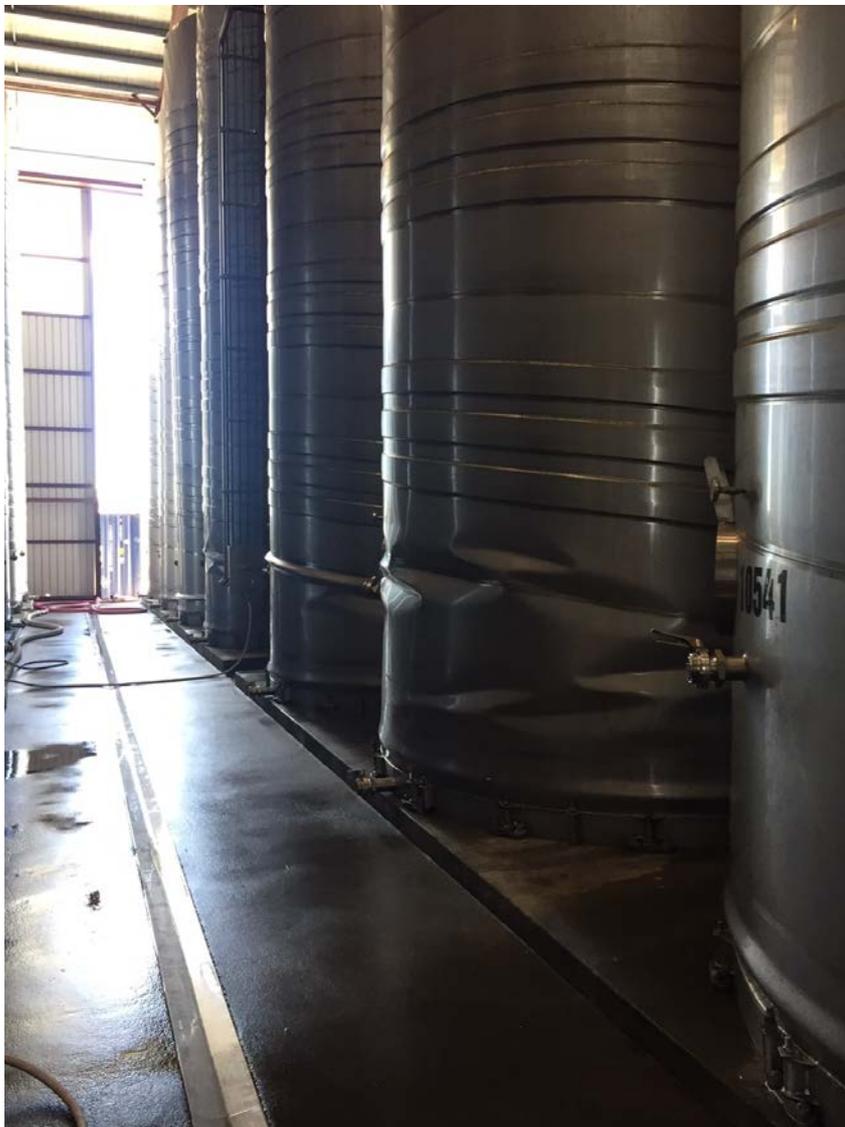
**Figure 5:** ‘Elephant foot’ bulging in the walls of the fermentation vats. The stainless steel tie-downs are just visible and are spaced at roughly 50 to 75cm around the perimeter at the base of the vat on the concrete pad.

Secondly there was some limited damage to the glycol cooling channels on a few vats but the most common category was the ‘elephant foot’ at the base of the vats that occurs when

~150 tonnes of must (the fermenting grape juice) after being lifted by vertical ground accelerations comes smashing back down (Figure 5).

The 'elephant foot' bulges are reparable by welding in a skirt on the inside. This work was already underway with tank fitters coming from Timaru.

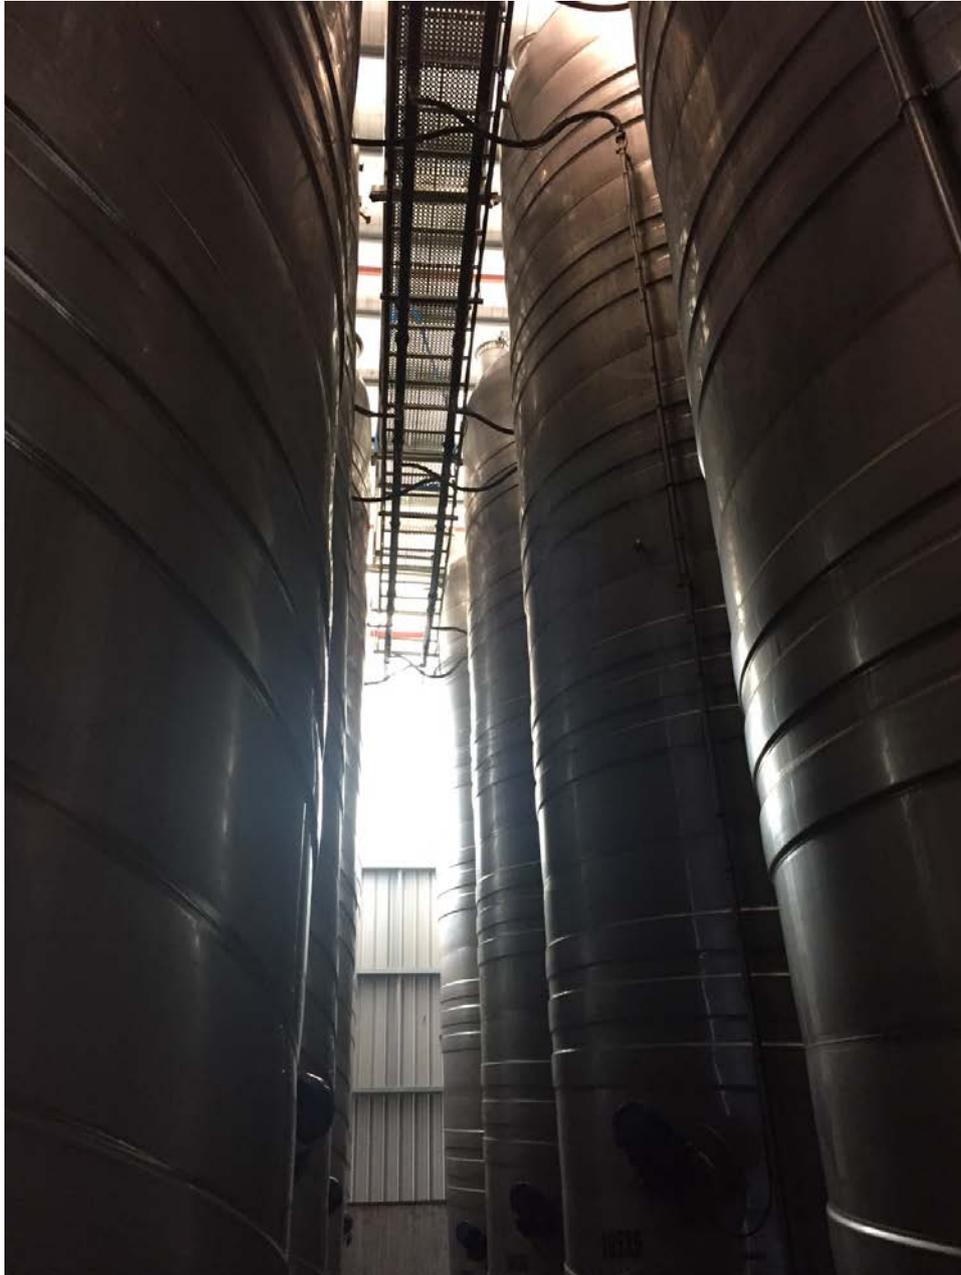
**Figure 6:** A tank leaning against the catwalk.

The forms of damage have been seen before: first there was some distortion to the tops of vats where these either banged against each other or against the elevated cat walks that allow winemakers access the top of these vats (Figure 6). It was incredibly lucky that the earthquake occurred at night when no one was in the winery.
