## 22 February 2011 Lyttelton earthquake, Briefing 2

Matthew Mason & Rob van den Honert

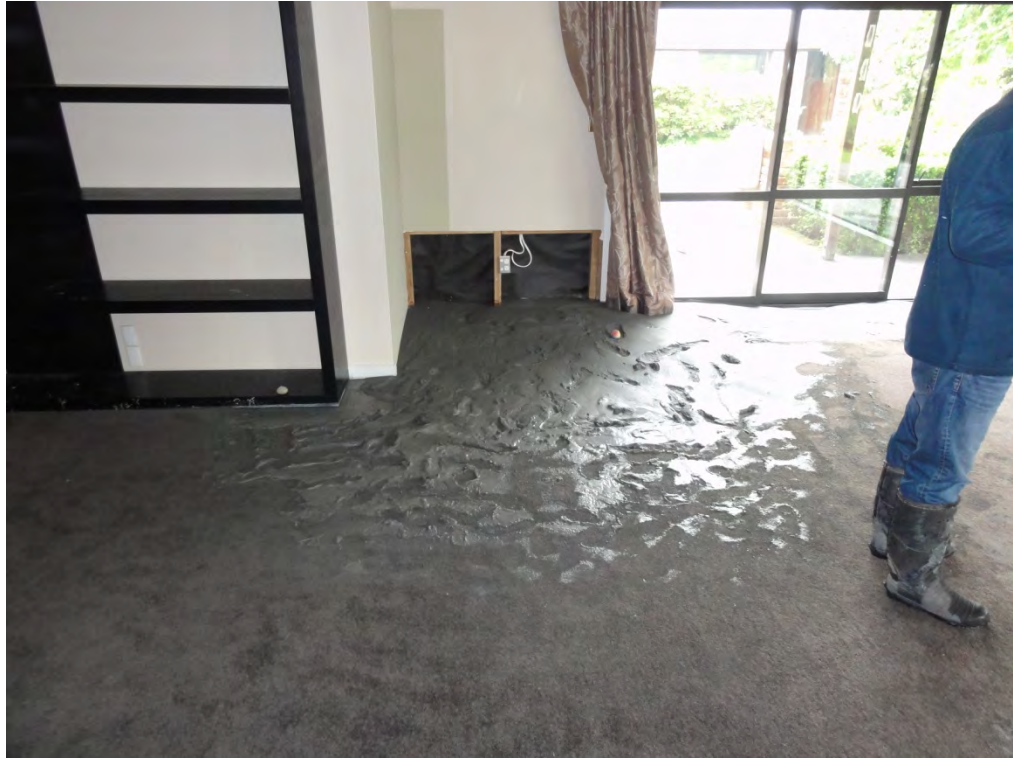
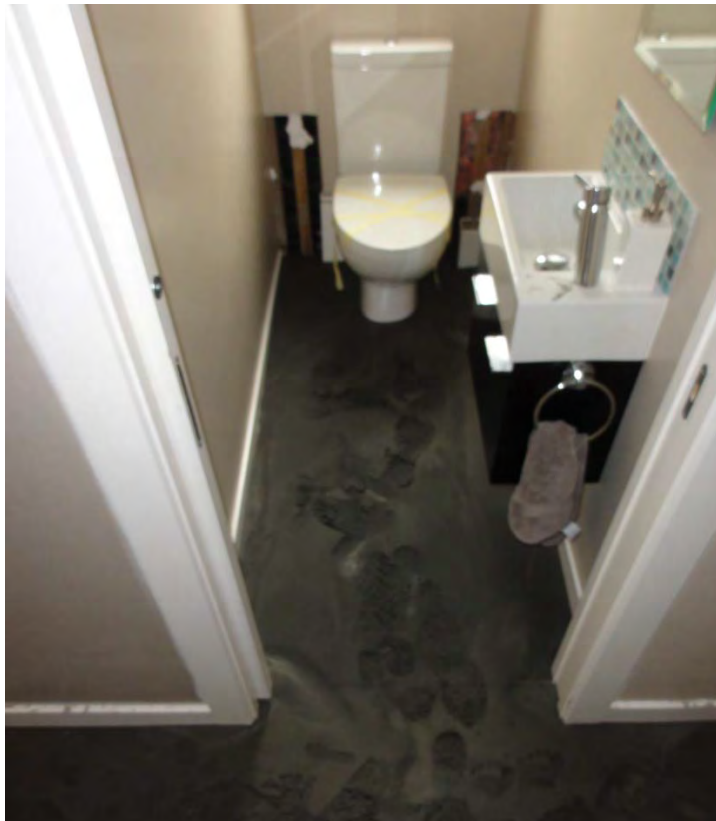
To exemplify the type of internal damage liquefaction can cause Figure 1 shows a home in Halswell rendered uninhabitable by the quake. Every room on the lower storey was affected by ejected silt and water intrusion. All carpets were wet underfoot and needed removal, and a layer of silt on the order of 10 cm deep covered much of the floor. In this case liquefaction had caused the slab itself to crack, settle and tilt, and the owner had been advised his home would be written off. Although the overall impact of liquefaction in the Halswell region was less during this event compared with the September earthquake, the impact on this home was greater this time.

Figure 1. Damage to the living room (upper image) and bathroom (lower image) of a home in Halswell.

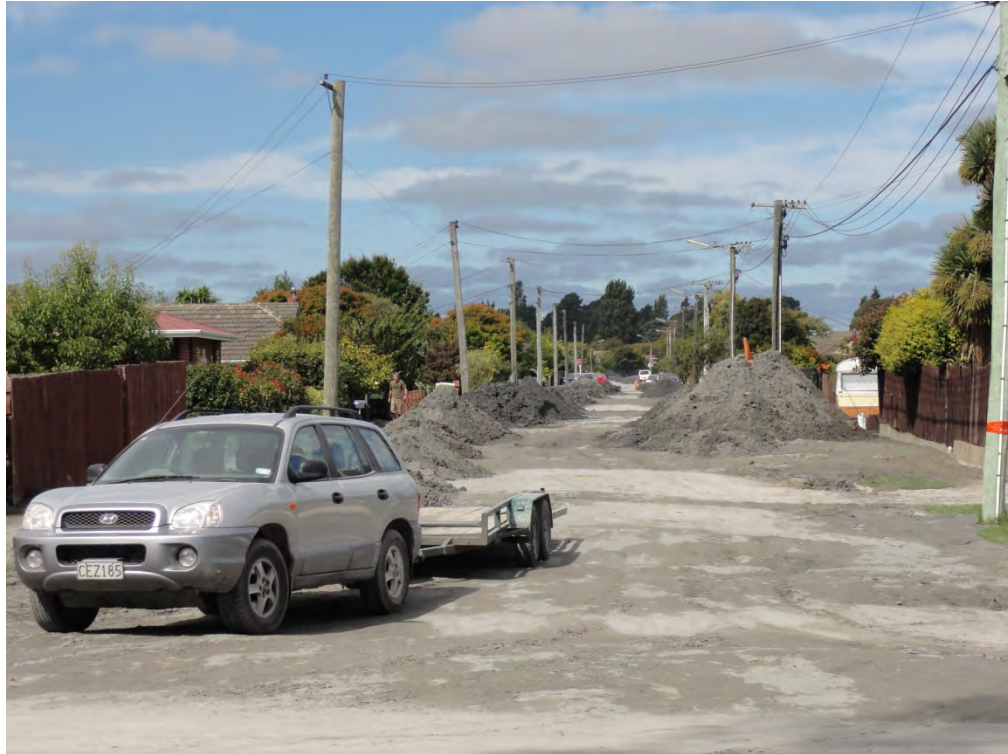
Worst affected suburbs included Avondale, Wainoni, Avonside, Aranui, Shirley, Richmond, Dallington and Bexley all to the north-east and east of the city, with Charleston, to the south, also badly affected. The enormity of liquefaction, and the problems faced by residents is evident in the ejected silt piles shovelled from homes and yards to the streets of Avonside (Figure 3).

Figure 3. Piles of shovelled silt from roads and homes, Avonside.

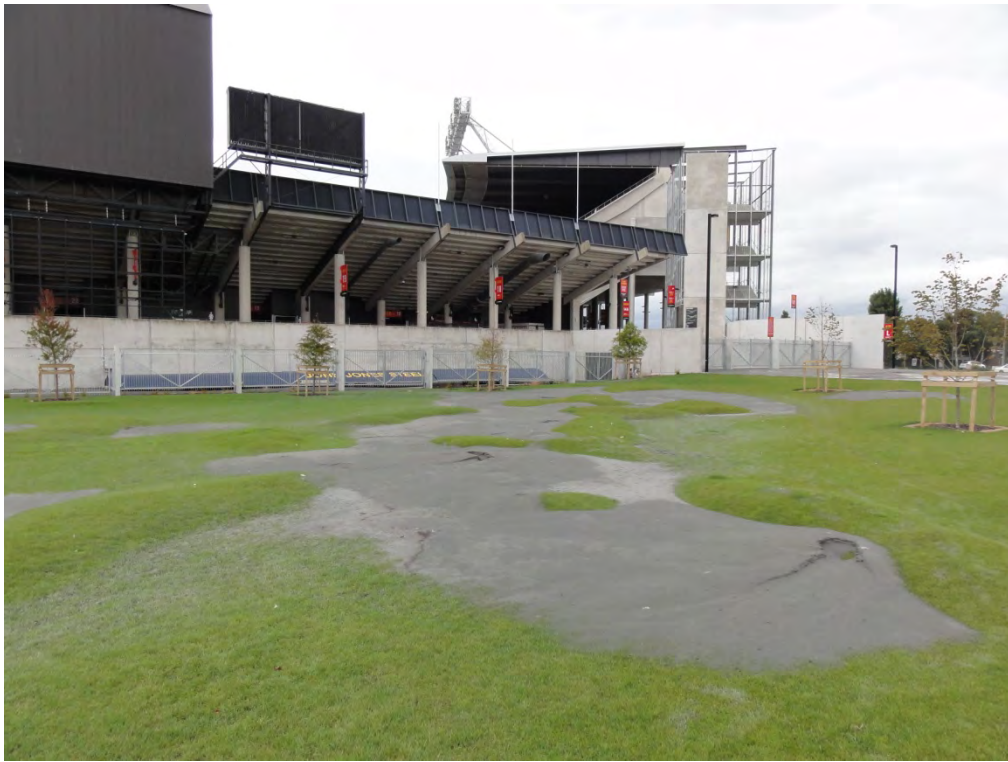
For Rugby mad New Zealand, the extensive liquefaction around and on the pitch of AMI Stadium (Figure 4) is a further cruel blow. Some structural damage to the stadium was evident, but is, reportedly, repairable.

Figure 4. Sand volcanoes around AMI Stadium.

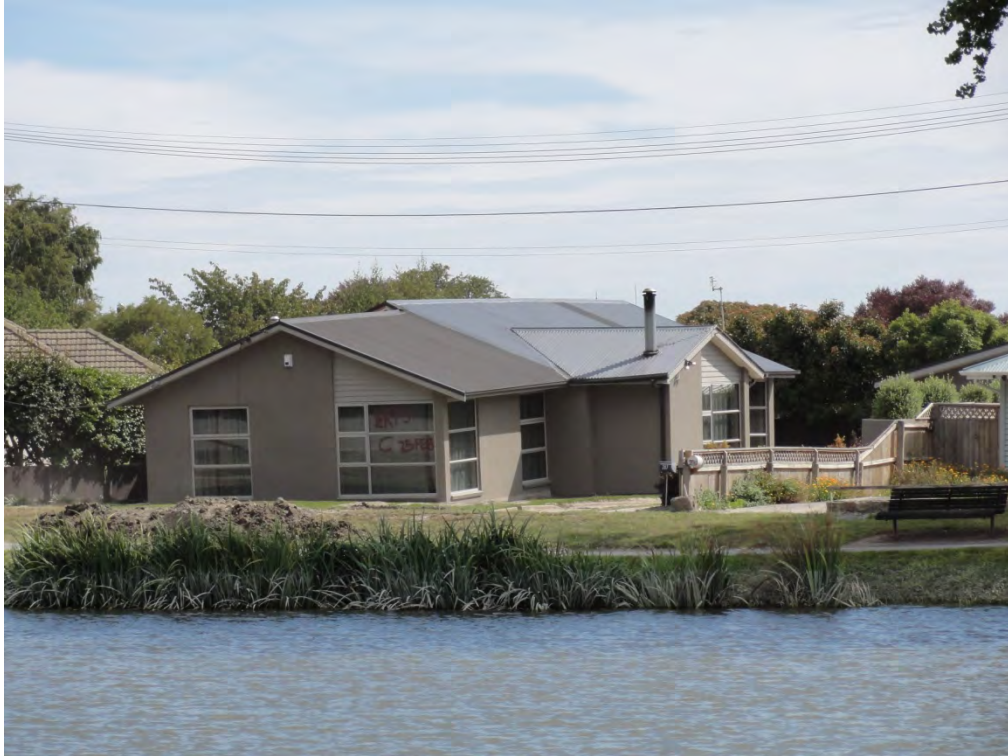
Almost all suburbs surveyed showed some signs of liquefaction. The direct impact of liquefaction on the structural systems of housing was in several cases clearly evident. Figure 5 shows a home ominously leaning towards the Avon River, Figure 6 a home whose foundation was undercut by lateral spreading and Figure 7 a home where settlement has cracked brickwork. Unfortunately many other cases will exist where serious damage to foundations has occurred with no outward signs of distress to the building – discussion with several residents proved this to be so. Liquefaction induced slab failures, often leading to homes being written off, will again be a costly component of this event's losses. Major failure of roads due to liquefaction was wide spread (Figure 8).

Figure 5. Tilting of home most likely due to lateral spreading.

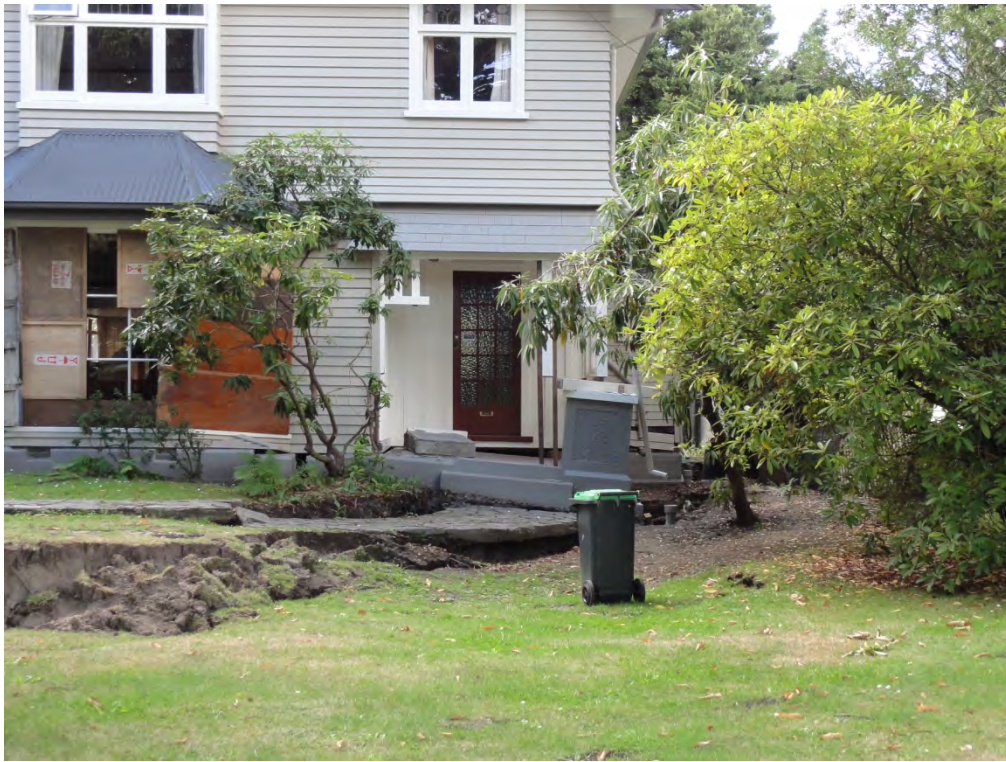
Figure 6. Undermining of foundation through lateral spreading.

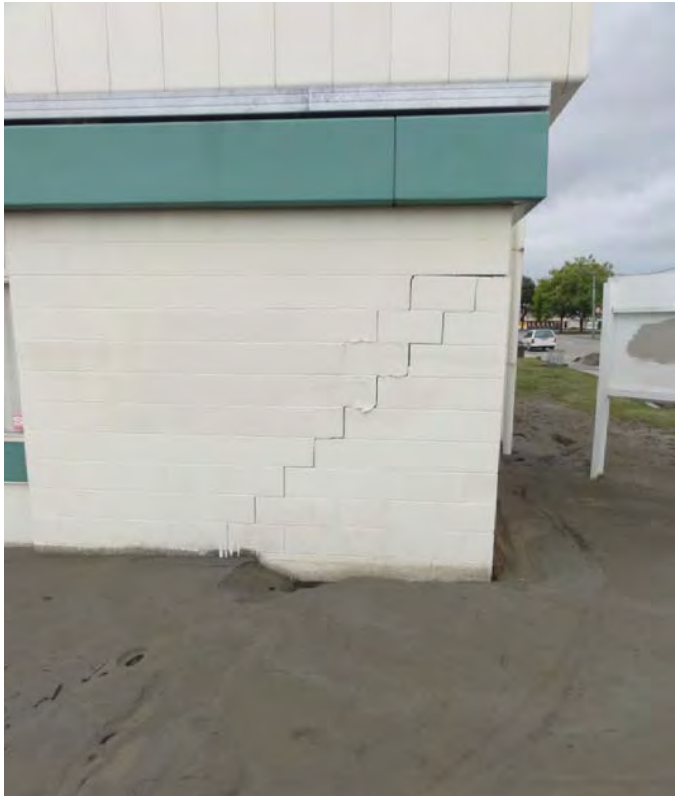
Figure 7. Cracking of building caused by liquefaction.

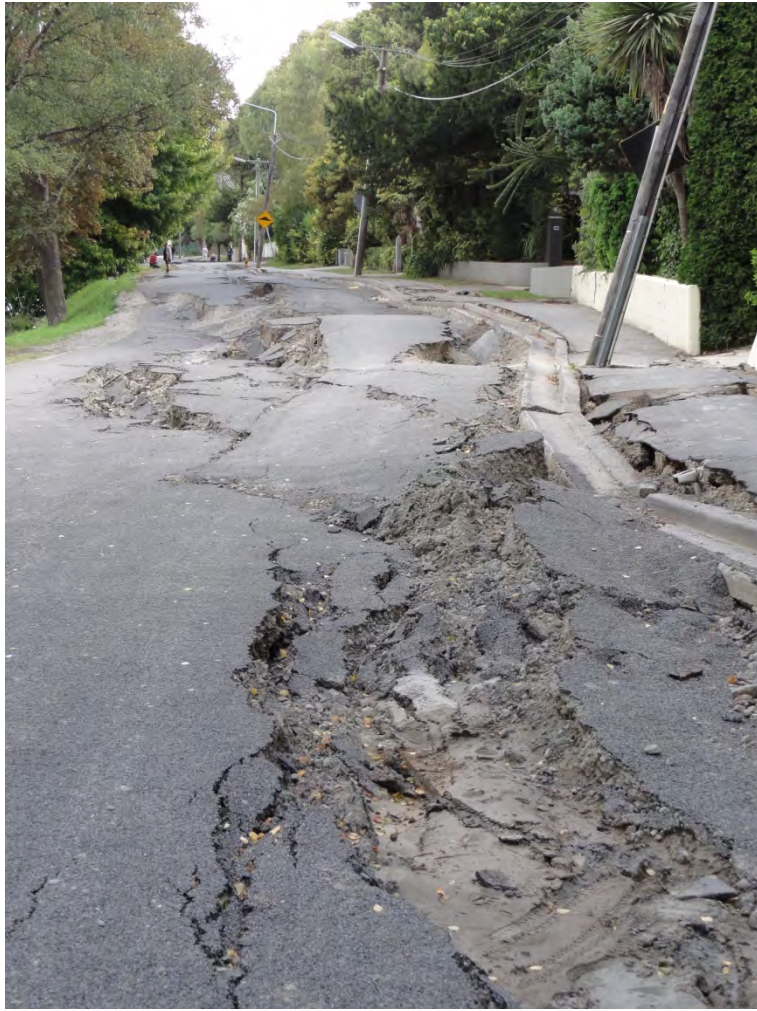
Figure 8. Damage to road along Avon River.
