22 February 2011 Lyttelton earthquake, Briefing 3

Matthew Mason and Paul Somerville

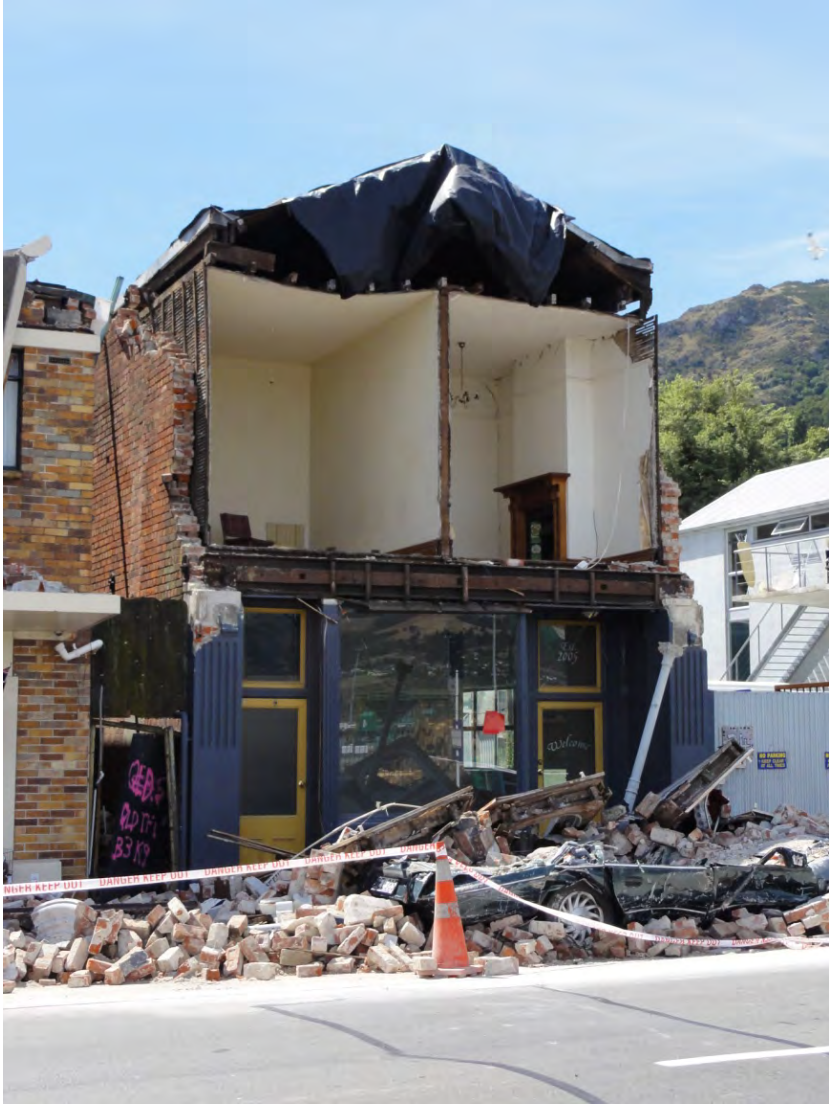
Damage to buildings in Lyttelton was extensive. As after the 2010 event, historic pubs and hotels were hit hard. Almost all buildings in the first two blocks off the port were "red stickered", with many looking well beyond repair. Failure of unreinforced masonry parapets, facades, chimneys and veneers were common (Figure 2) on both residential and commercial buildings. Where reinforcing (or at least restraining) work had been done after last year's quake, buildings, in some cases, appeared to avoid total façade collapse but in others did not. In all instances failure of unrestrained portions of the façade were observed. A common sight was for timber-framed, partially brick-veneered buildings to have lost part or all of their brickwork, but for adjacent walls clad in timber to outwardly appear intact. Given the much greater ductility of timber this was probably an inevitability.

Figure 2. Failure of gable end and upper storey facade. Note the unfortunately parked car on the street below.

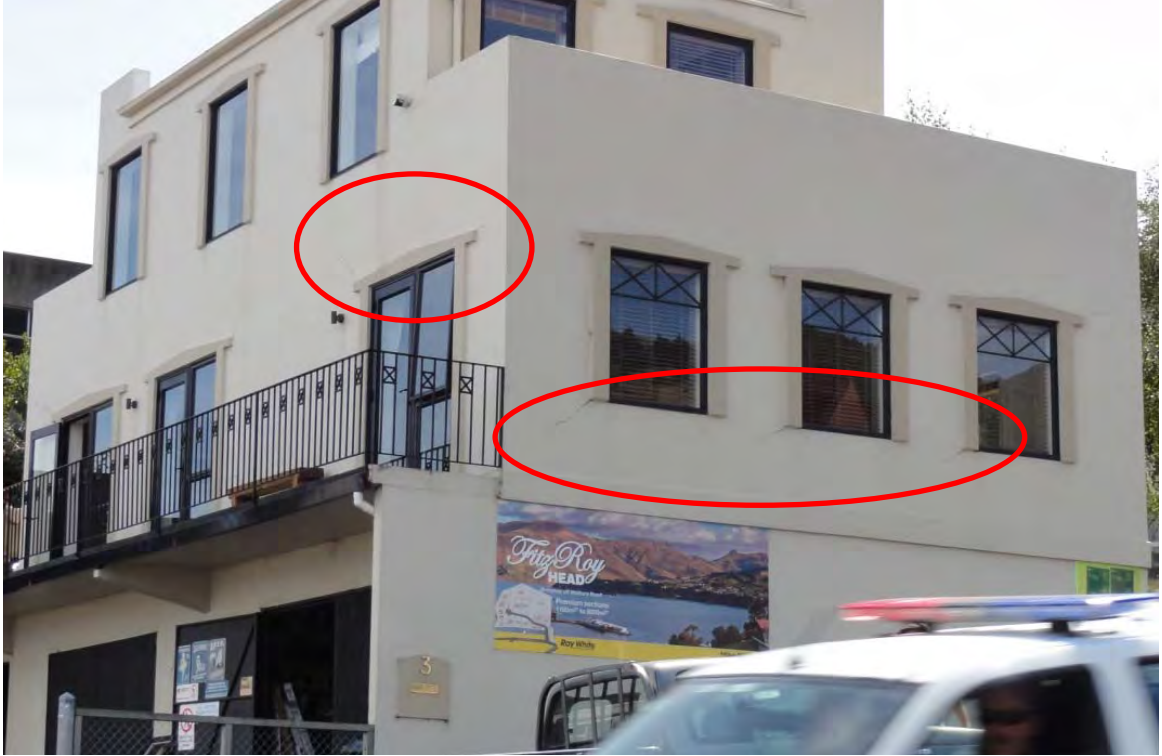
Cracking was noted on a few newer buildings (Figure 3), but structural integrity appeared in all cases to be maintained. With ground accelerations in the area greater than specified in the earthquake standard, this performance is a good reflection of the stringent application of the building code in New Zealand.

Figure 3. Cracking from edges of door and window frames, but no failure of newer buildings.

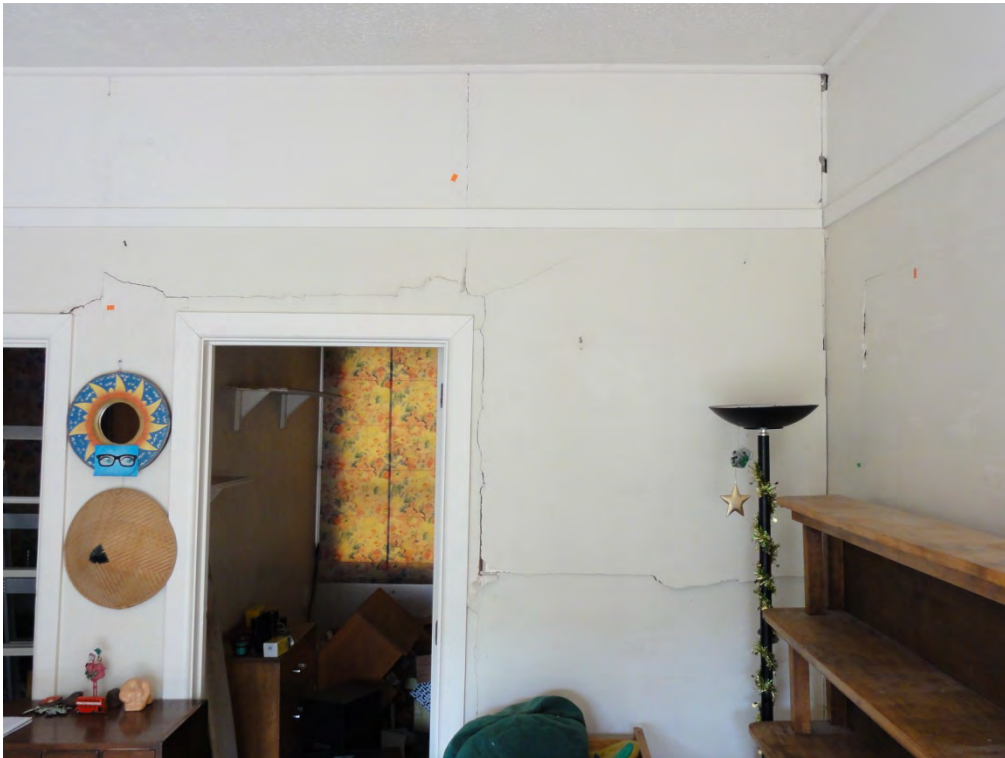
We were fortunate to have the opportunity to thoroughly inspect (roof and sub-floor cavities included) a timber framed and stumped home on the western hills of the city. Despite the house displaying little evidence of stress to any major structural elements, extensive cracking to internal walls and glass windows and doors was extensive (Figure 4). Again, given the greater ductility of framing compared with wall sheeting this is expected. Discussion with the owners – over a cup of tea and a sandwich – suggest the extent of damage they experienced was common around the town, with everyone they'd spoken to having at least extensive internal cracking and breakage. As a point of interest, two neighboring concrete block homes were red-stickered and slated for demolition.

Figure 4. Extensive internal cracking of timber framed home.

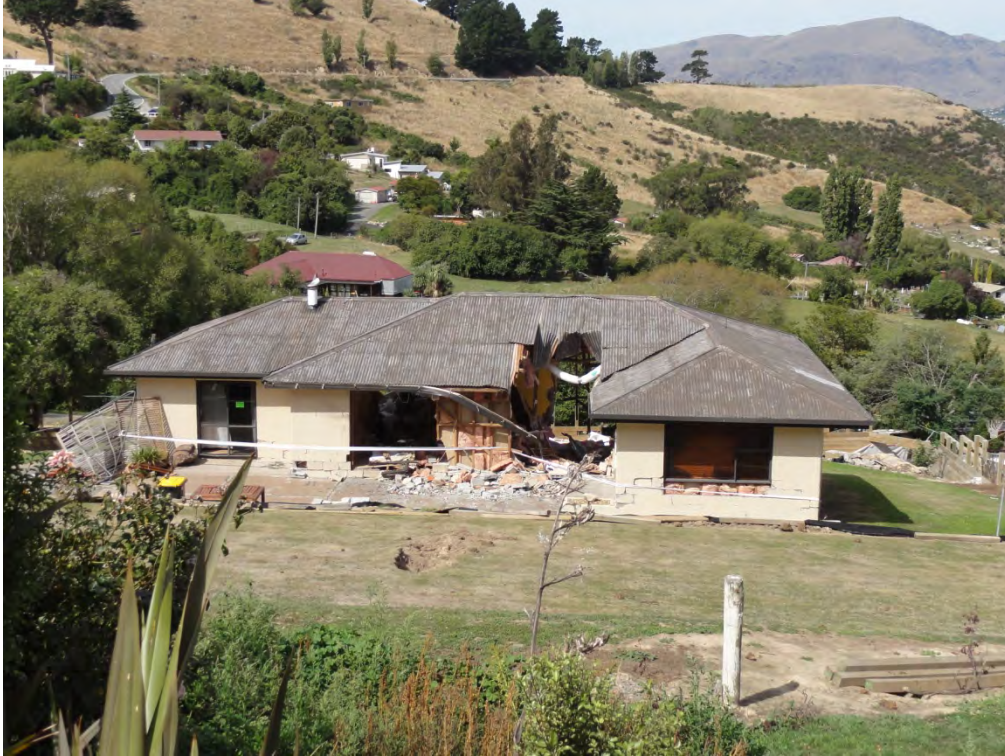
Given the mountainous terrain of the Lyttelton area rock retaining walls are common. A large number of failed walls were noted with damage to roads common and damage to homes reported. In the neighboring town of Rapaki major boulder impact damage was seen (Figure 5). Fortunately for the town other large boulders had stopped part way down the slope before reaching it.

Figure 5. Damage to home due to falling boulder.

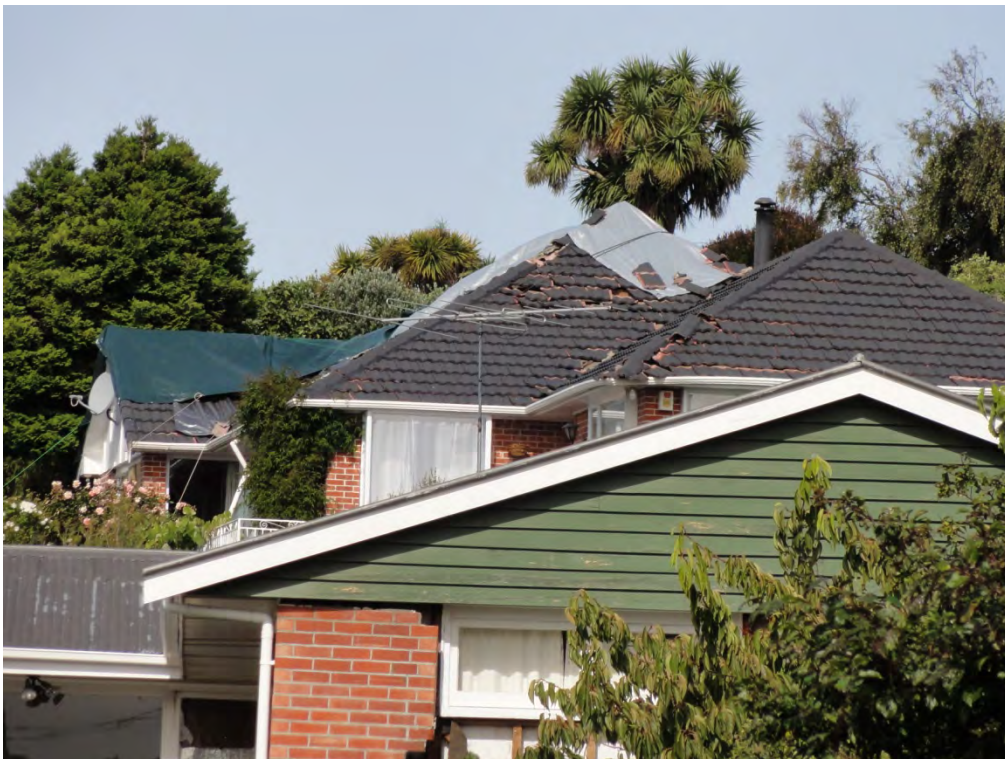
Shaking damage to the accessible suburbs on the northern face of the Port Hills and valleys (Ferrymead, St Andrews Hill, Mt Pleasant, Heathcote Valley) was extensive. The Heathcote Valley School recorded the highest peak ground acceleration for the event at greater than 200% g. Cracking was common on block and brick homes, with veneer failures regularly noted. Failure of double brick walls was also common, but no complete home collapses were sighted. Dislodgement and loss of tiles on steep sloping roofs appeared to be an issue, with even newish housing suffering (Figure 6). Loss of tiling was noted in other areas of Christchurch also – the higher the pitch the more prone to failure they appear to be.

Figure 6. Damage to newer tiled roof.

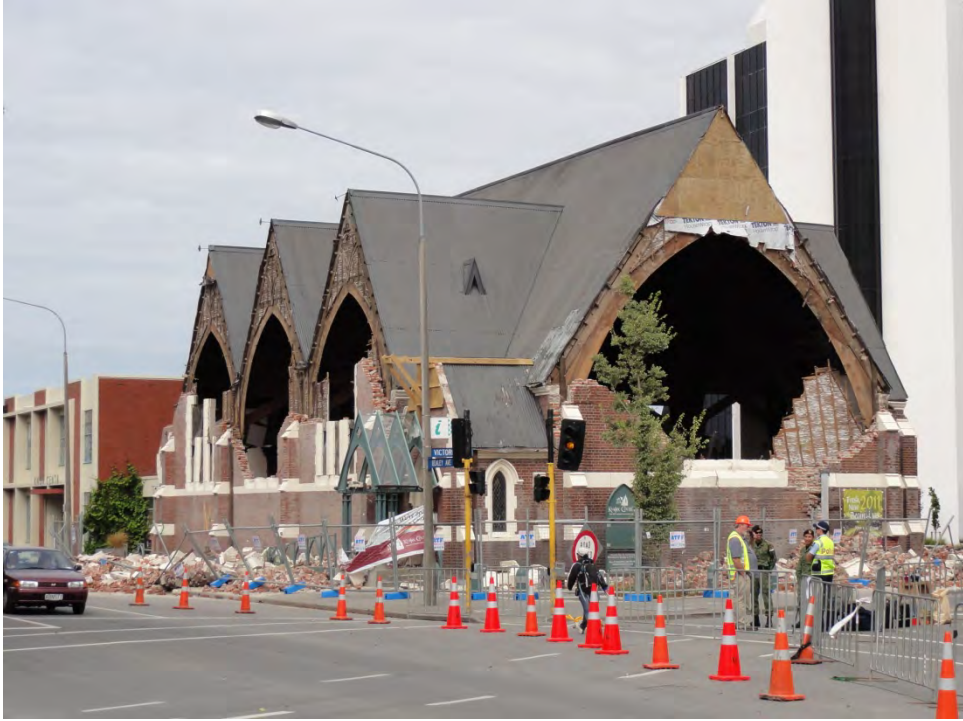
Unfortunately we were unable to gain access to the CBD. Inspecting damage from the city cordon though, extensive damage was obvious. Now well reported, damage to many of the city's iconic buildings (Figure 7) was such that a number will be brought down (Figure 8). The poor performance of unreinforced masonry buildings was again highlighted, but the impact of failures in the city was far greater than in the suburbs because the density of buildings and people (at the time) was much higher. A historic reluctance to retrofit older buildings left them under-prepared for resisting earthquake forces; this was a costly mistake (socially and financially).

Figure 7. Loss of gables on the Presbyterian Church.

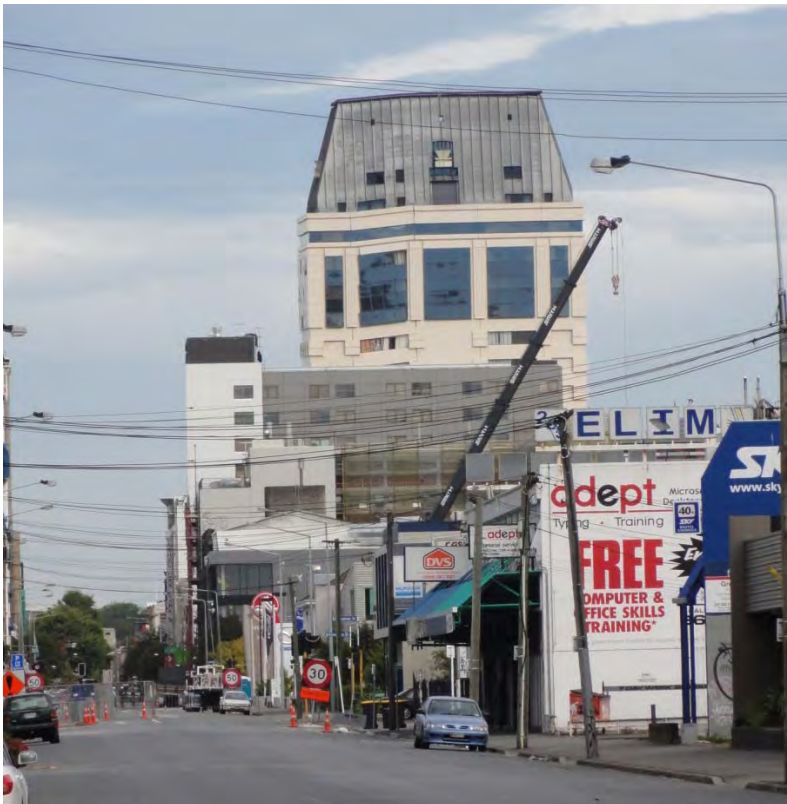
Figure 8. The noticeable lean and kink of the Grand Chancellor Hotel.

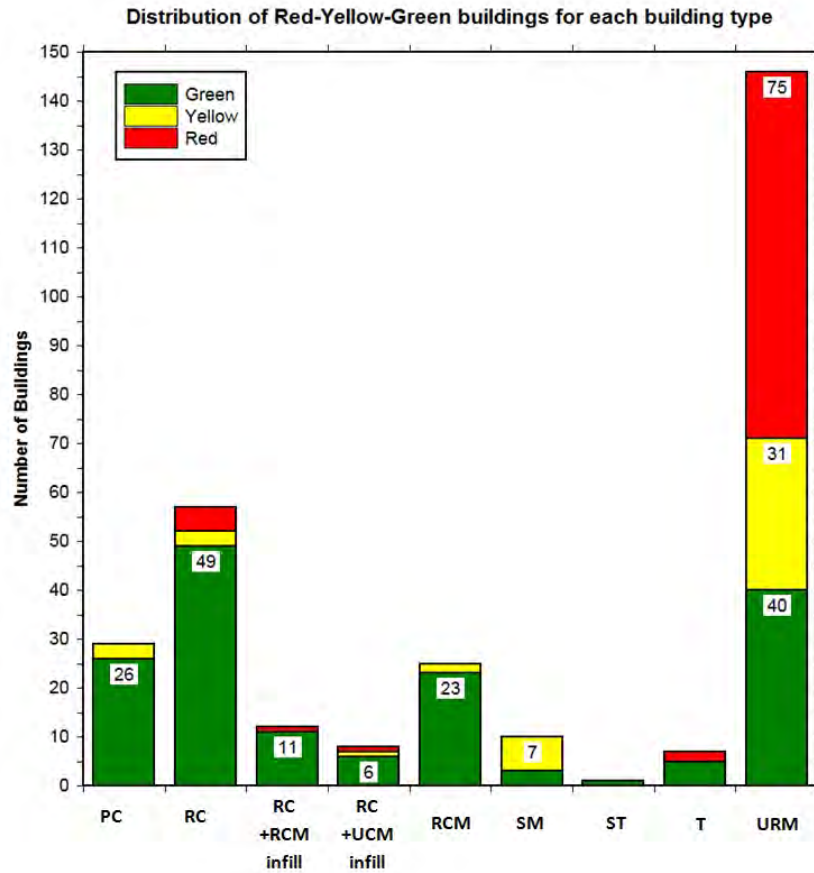
Radio reports suggest around 20 – 30 % of buildings within the CBD will be demolished. A/Prof. Jason Ingham from the University of Auckland, after conducting an assessment of a portion of the city's buildings (300 buildings) reported that approximately 50% of all unreinforced masonry buildings, which make up about 50% of the city's building stock, were

likely to be demolished (Figure 9). As expected, unreinforced masonry (URM) buildings performed worse than other building types, but poor performance of some reinforced concrete (RC) and timber (T) structures was also noted. Ingham believes up to 35% of the city's buildings will need to be demolished.

Figure 9. Damage levels to a transect of buildings in the Christchurch CBD (Jason Ingham, available [here](#)). Green signifies minimal if any damage, yellow, major but repairable damage, and red, extensive damage likely requiring demolition.

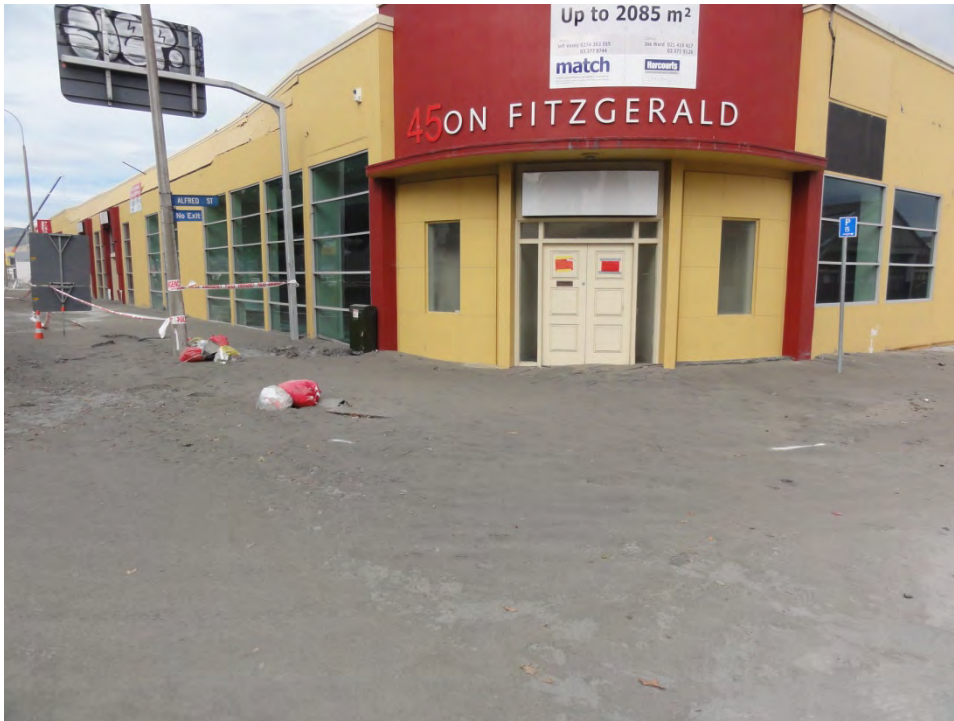
Liquefaction was evident on a number of streets and around many shops heading into the CBD (Figure 10). Refer to Table 1 for a description of affected streets.

Figure 10. Liquefaction around shop entrance on city cordon. Note also cracking to parapets.
