March 2005 Volume 4 Issue 3

# Risk Frontiers

## December 26, 2004 Sumatra Earthquake and Tsunami

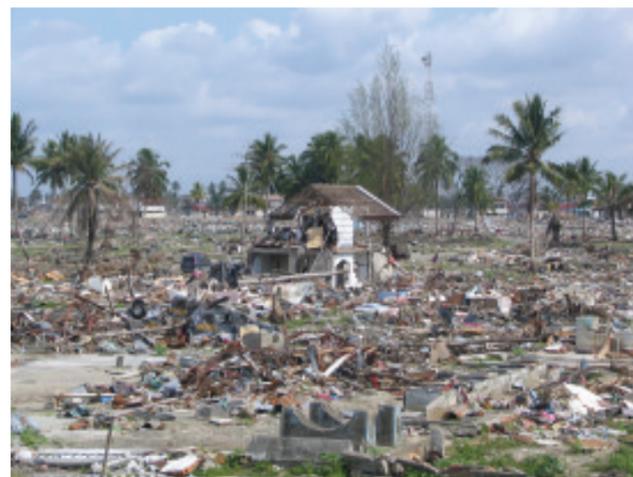
Let's begin with tsunami damage. Run-up height is highly influenced by offshore bathymetry and on-shore topography and not surprisingly the level of destruction varies widely. Most coastal settlements in Sumatra occupy alluvial plains only a meter or so above sea level. On the peninsula at Meulaboh (Figure 3), waves attacked from three sides and damage to the military HQ can be seen to 8m above the current sea level. Few non-engineered structures can withstand such associated hydraulic forces and, as a result, some towns, such as Calang, no-longer exist. They have been simply blitzed! Further north at Lhok Nga only a lone mosque survives in the midst of a denuded landscape.

**Figure 3:** On the peninsula at Meulaboh – waves attacked from three sides.

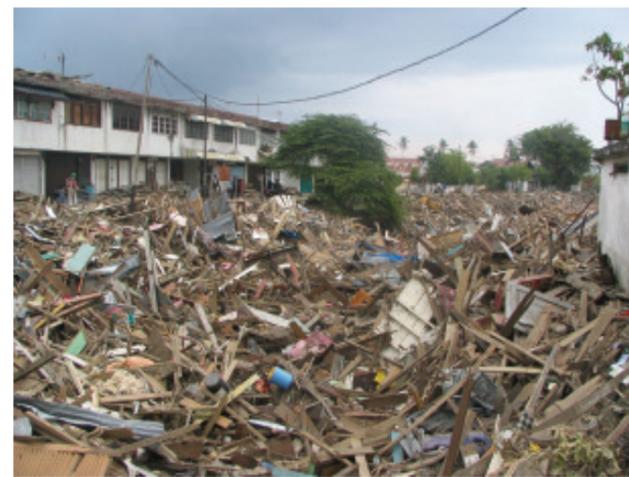
About 60% of Aceh's most populous city affected, Banda Aceh, was leveled by wave heights of 10m at the shoreline. Much of the debris from this destruction, spanning more than 3km, was swept into the town's centre where it caused additional damage and loss of life. Water heights here were around 3m and destroyed most of the city's commercial activity, even where buildings remained structurally intact, as lower storey shops and businesses were filled with jetsam (Figure 4).

**Figure 4:** Rubble and death in the CBD, Banda Aceh

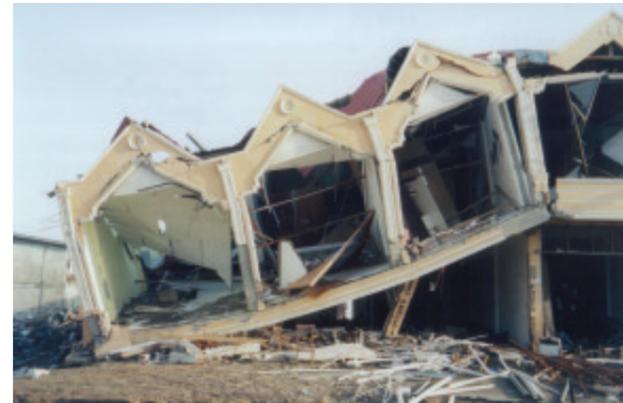
In addition to the impact of the direct hydraulic forces, floating objects acting as battering rams also cause damage. (Similar effects are also true of cyclones.) This debris can destroy buildings that may otherwise have remained standing (Figure 5). Scouring may also undermine supporting walls.

**Figure 5:** A building with a structural wall taken out by the force of water or floating debris.

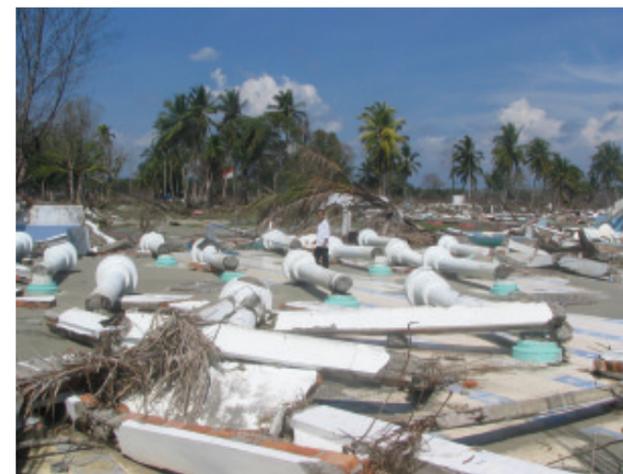
**Figure 6:** Not all mosques survived.

- \* Low cost wooden buildings rarely survive wave heights of 2m.
- \* Mosques generally fare better than residential buildings due to their massive construction and open lower structure that allows water to flow through and equalise pressures (See Figure 6).
- \* Some hotels with open lobbies may survive for the same reason as do many mosques.

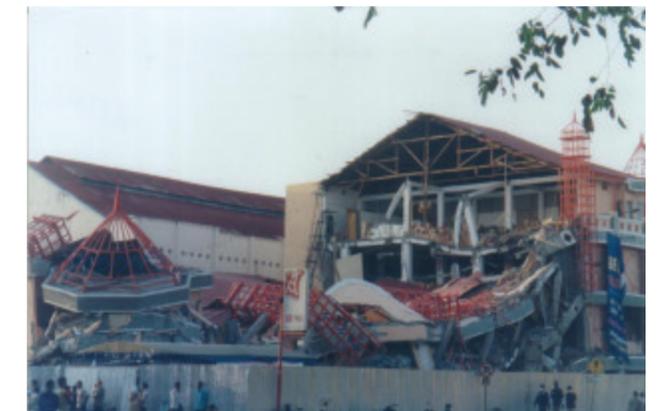
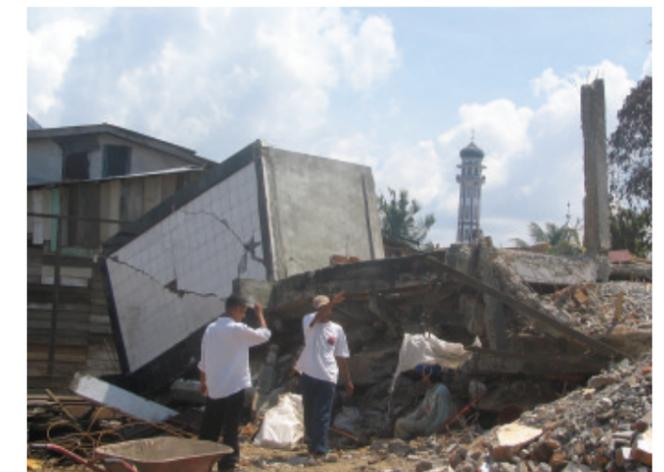
A few words now about damage due to ground motions from the earthquake. In those parts of Banda Aceh and Meulaboh untouched by the tsunami, there are some spectacular examples of pan-caked buildings. These structures mostly had 3 to 6 storeys. Since the majority of similarly constructed buildings survived unscathed, it is tempting to ascribe these failures to poor engineering design or construction. At least in some of these cases, some standard faults such as the 'strong-beam weak column' design are obvious as is the common use of non-deformed (smooth) reinforcing steel.

**Figures 7 & 8:** Earthquake damage.
