Briefing note
466
Apr 2022

NSW Far North Coast & Northern Rivers flood impact research, March 2022

by Steven George, Maxime Marin, Stuart Browning, Andrew Gissing, Risk Frontiers

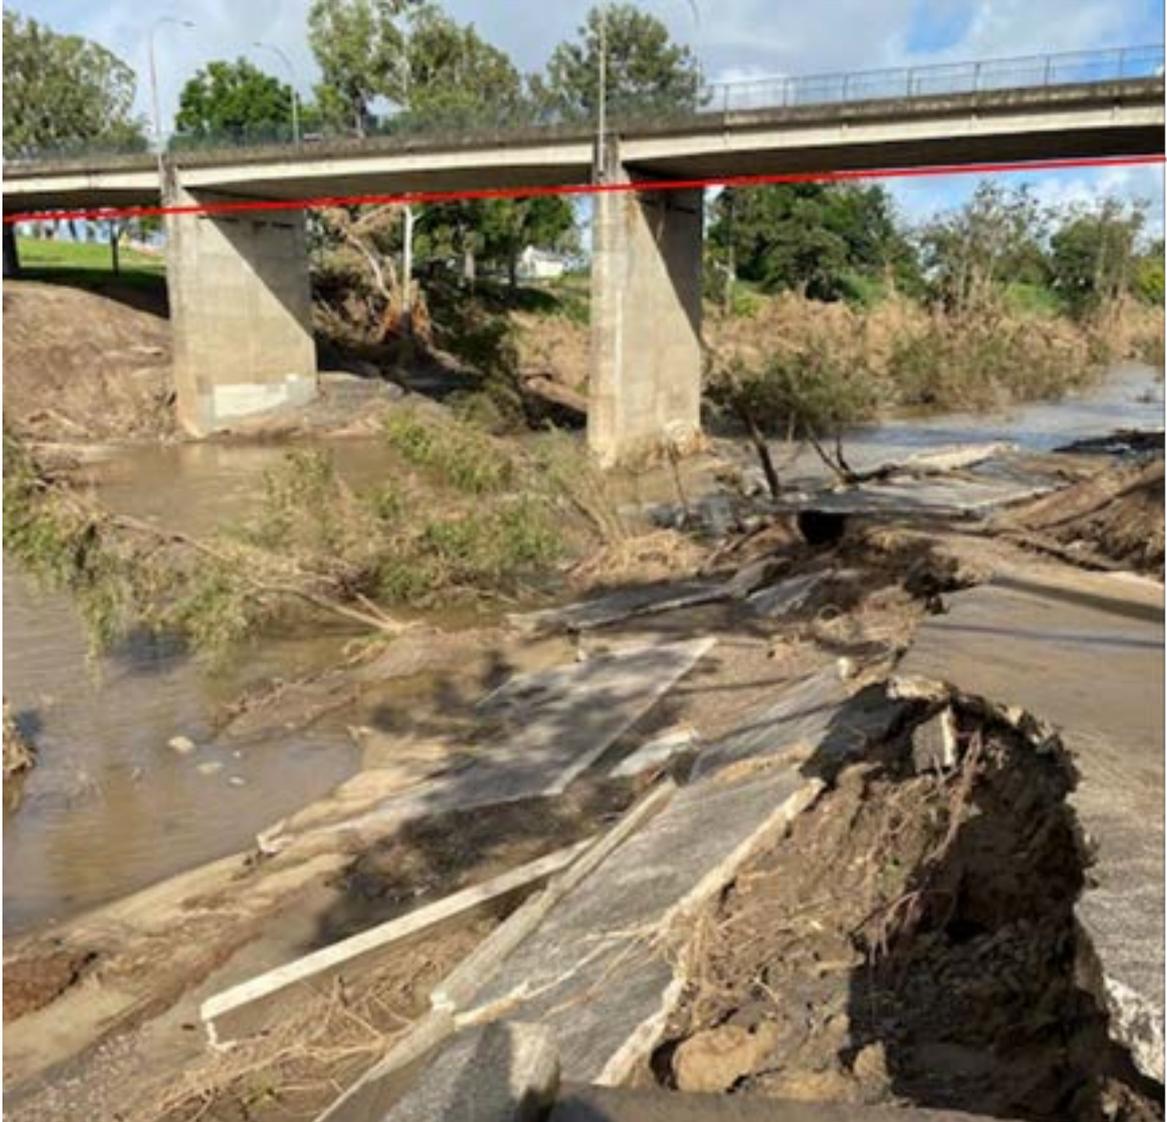
- Reports from shop owners in the city centre were that the CBD was inundated by between 40 - 60cm of water
- Some shop owners thought that widespread complacency among businesses (from many years without experiencing floods) had prevented many from making preparations such as moving stock. Businesses took well over a week to reopen as a result.
- Significant erosion of the rivers banks was evident, as was a destroyed roadway beneath the Irving Bridge (Figure 3).

Figure 3: The Richmond River in Casino beneath the Irving Bridge. Red line indicates the approximate peak height of flooding on the 27th of February. Note the destroyed roadway and trees lain over by the force of flood water.

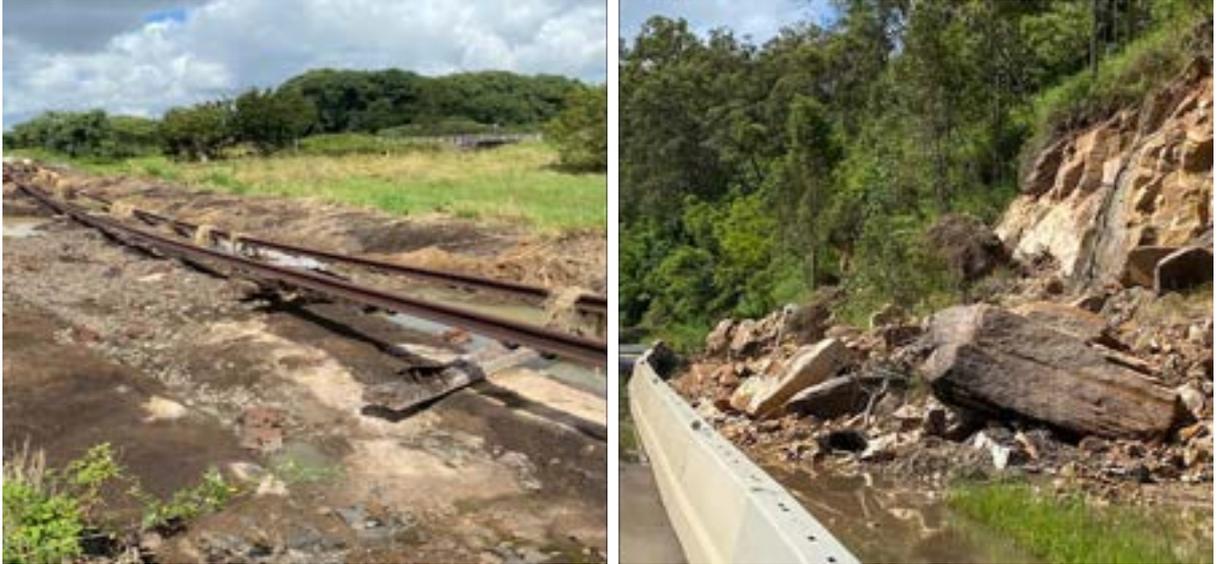
- A businesswoman who owned multiple stores that had been flooded spoke of her surprise of the height of the peak flood levels. Being higher than expected meant that preparations proved insufficient.
- Between Casino and Lismore, there were numerous examples of infrastructure damage (from flood waters) and landslides from heavy rain (Figure 4). Some roads between the two towns were still closed to general traffic because of rockfalls and damage to roadways, causing detours to be put in place.

Figure 4: Washed out railway line (left) on Naughton Road between Casino and Lismore and a rockslide (right) closing one lane of Bentleys Road approximately 10km from South Lismore.

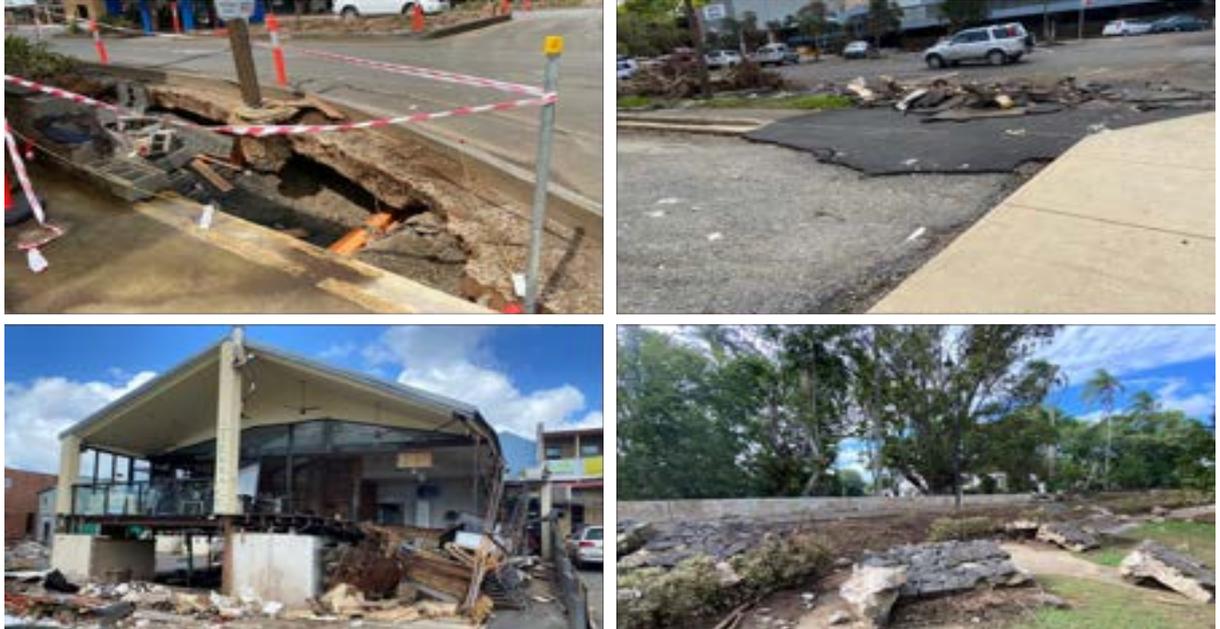
- The Lismore CBD was extensively impacted with examples of structural damage to: storm drains and gutters; stone and concrete walls adjacent to the river; and the rear of the Richmond Hotel, which had collapsed (Figure 5). Bitumen surfaces of car parks and roads had also been stripped away in multiple locations. There were also numerous examples of shops boarded up from broken shop windows and bent street signs. Businesses raised stock to levels above the 1974 flood level, to no avail.

Figure 5: Examples of structural damage in the Lismore CBD. Clockwise from top left - stormwater drain and gutter, car park surface, a stone wall adjacent to the Richmond River and the rear bar of the Richmond Hotel.

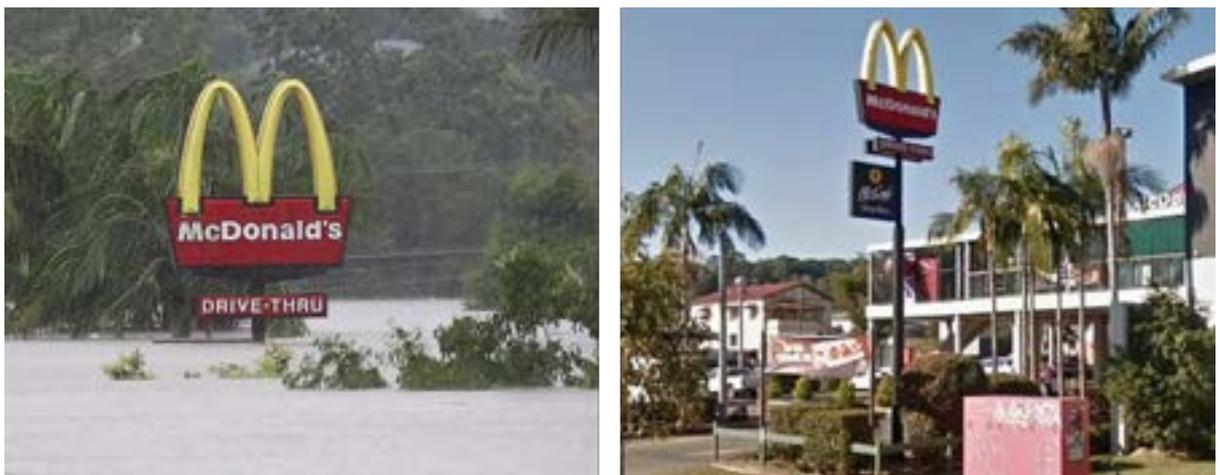
- Flood water in the Lismore CBD exceeded 4 metres, completely inundating most residential and commercial buildings and reaching to the top of telephone poles and other major business signage (Figure 6).

Figure 6: The flooded McDonald's restaurant and sign showing the height of flood water in the Lismore CBD on the 28th of February (left) and the same sign on the 18th of March (right) when survey teams visited (Image source (left): AAP images).

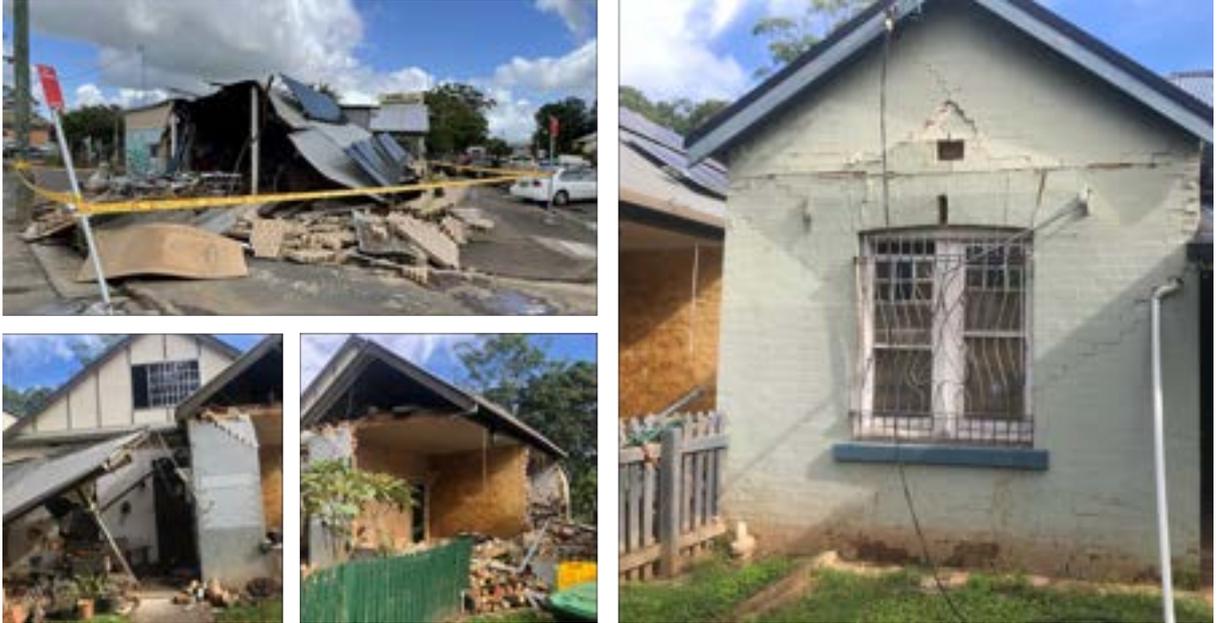
- Examples of structural damage to the exterior of homes and businesses in South Lismore ranged from cracked walls and masonry to partial or total building collapse (Figure 7).

Figure 7: Examples of structural building damage in South Lismore

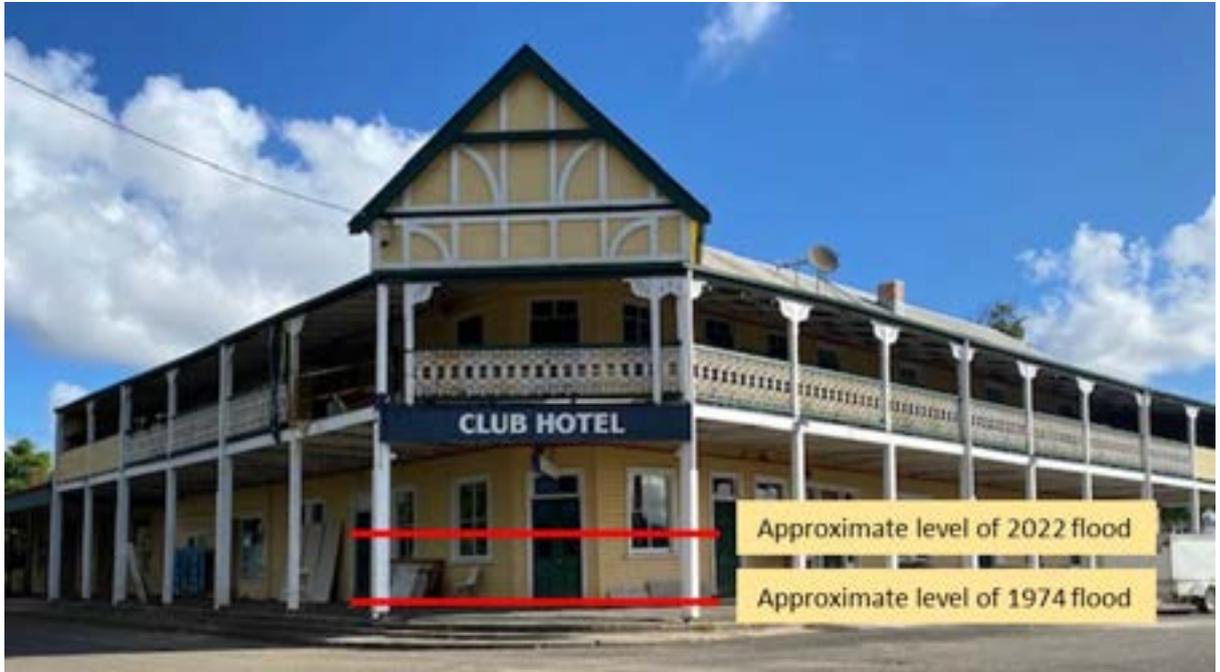
- Extensive flooding was evident throughout the town, with water levels > 2 metres in lower lying residential areas.
- The local hotel, which had just undergone a major refurbishment, suffered significant damage. Water levels rose quickly to approximately 1 metre above the 1974 level (Figure 8) and inundated the entire ground floor and destroyed antiques and an entire kitchen of brand-new appliances before they could be relocated.

Figure 8: The Club Hotel at Coraki.

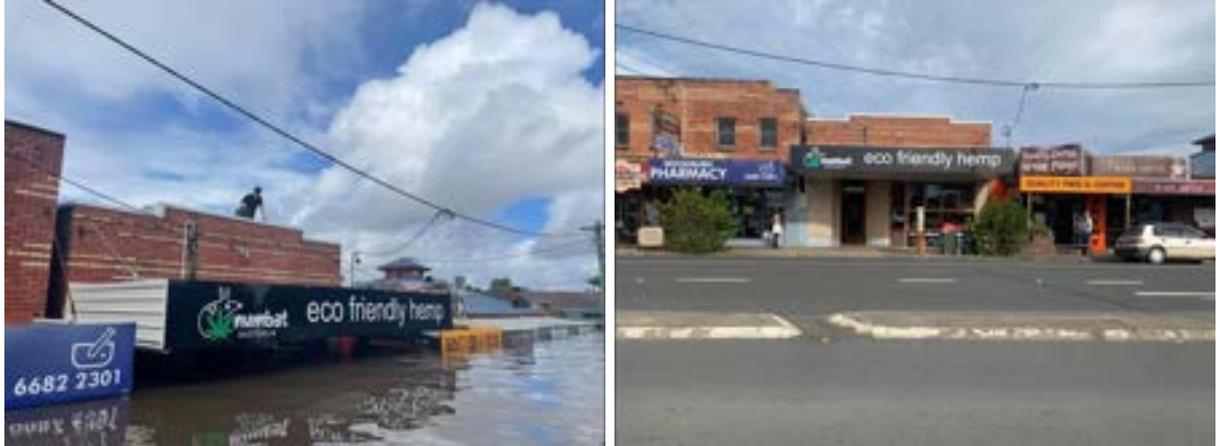
- Woodburn, directly adjacent to the Richmond River, experienced significant water depths, > 3 metres (Figure 9) and > 4 metres in lower-lying areas.
- One clothing store owner reported that warnings of the oncoming flood came far too late and had severely underestimated both the peak level of flood waters and the speed with which the water rose. The owner reported hastily moving floor stock to a high mezzanine storage platform inside his shop, although this too was inundated, causing the loss of approximately \$60,000 in clothing stock. There were also reports of looting occurring, with one offender being trapped by the speed of rising waters before apprehension.

Figure 9: The main Street of Woodburn on the 1st of March 2022 showing water levels from flooding of the Richmond River and a looter (on roof) taken into custody after being trapped on rooftops by fast rising water (left) and the same streetscape, unflooded (right). (Image source (left): Shop owner).

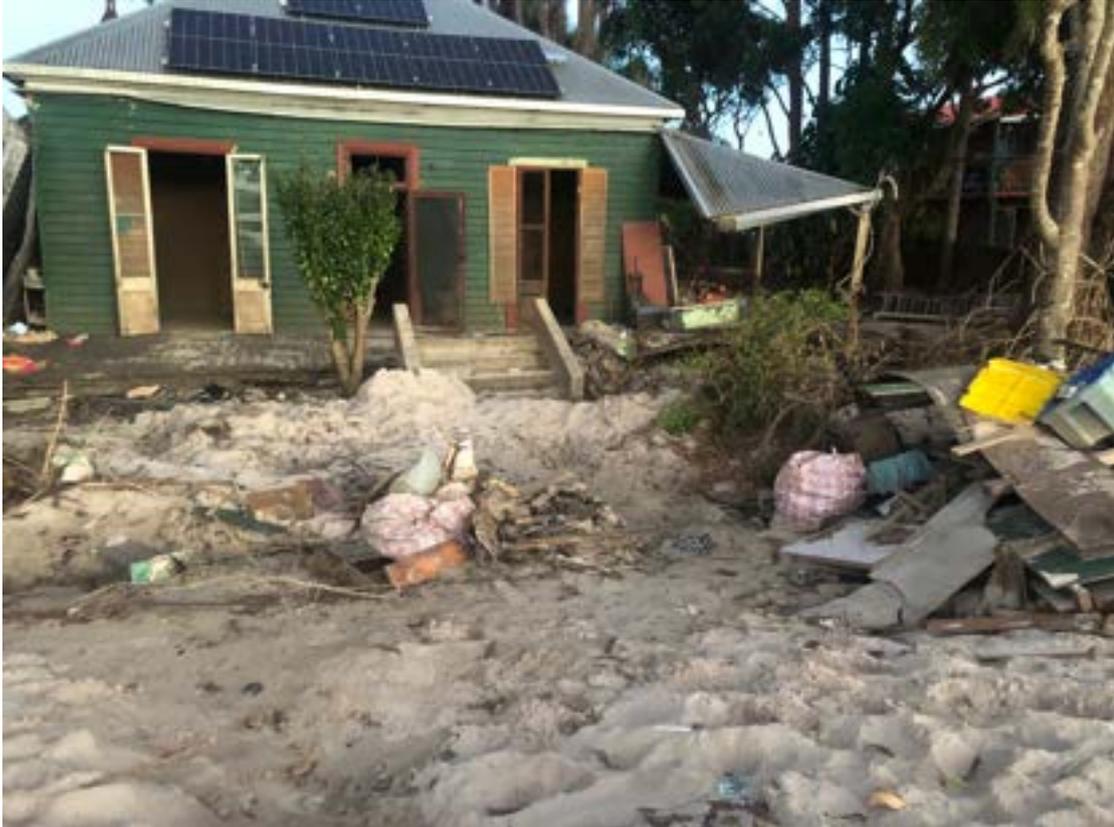
- A number of residences in Broadwater appear to have suffered structural damage to walls and outside extensions. There were examples of large sand deposits left behind by floodwaters in front yards and along roadways seen through the town (Figure 10).

Figure 10: Broadwater residence showing structural damage and large amounts of flood-deposited sand in the front yard.

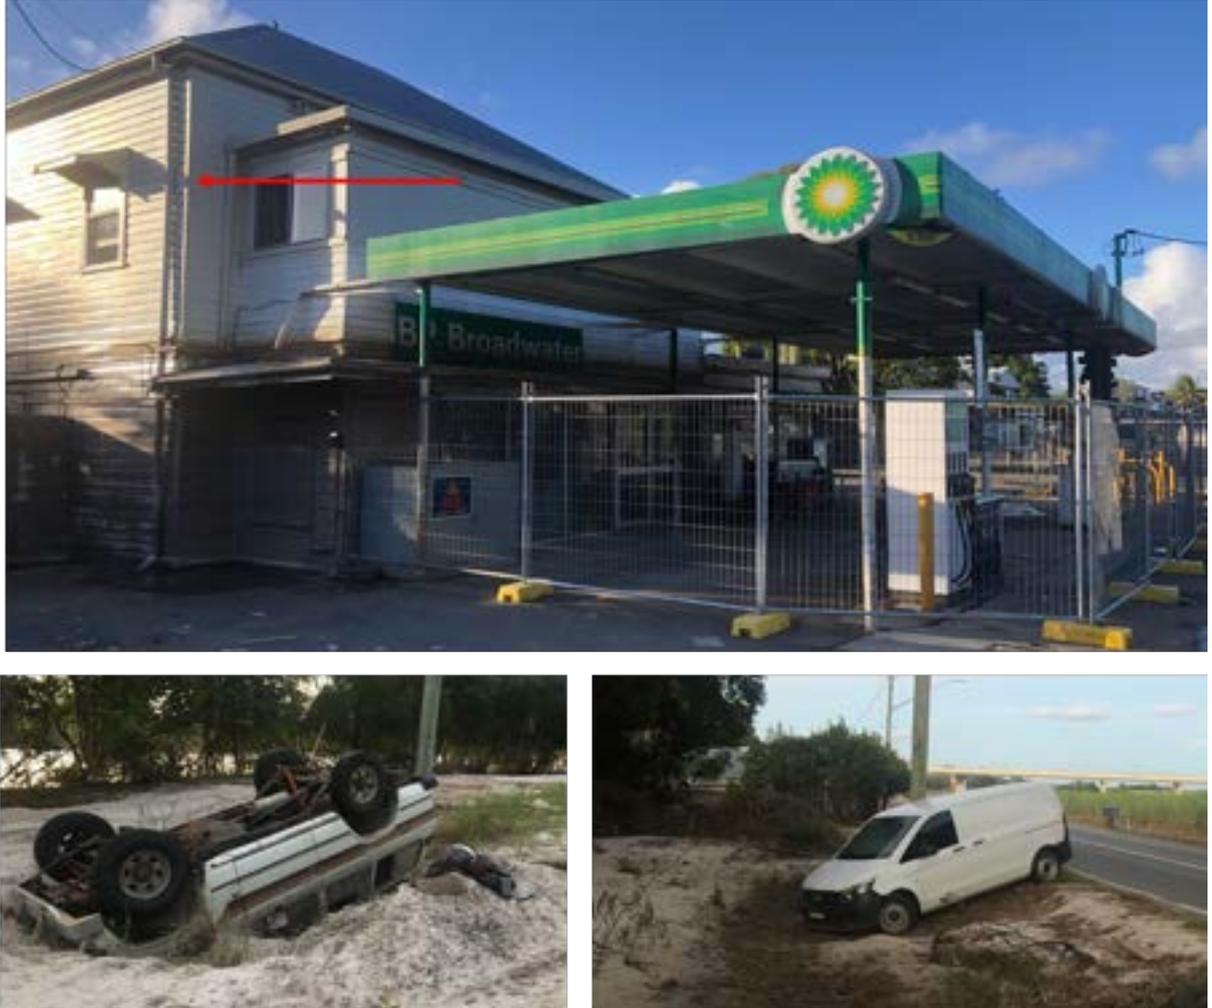
- The Broadwater Sugar Mill and Cape Byron Power Plant (occupying the same premises) were out of operation. Over 1.5 metres of water inundated the ground floor of the site which sits directly adjacent to the Richmond River. The mill and power plants are major employers in the area. Employees mentioned that operations could take months to resume.
- In some areas of Broadwater, flood heights exceeded 3 metres, with businesses remaining closed and premises showing the signs of significant inundation. There were also numerous examples of cars still lying on their sides and roofs among deposits of sand and other debris after more than two weeks (Figure 11).
- The vulnerability of caravan parks to flooding was again highlighted at the local park, where all dwellings had suffered severe inundation, some with structural damage.

Figure 11: The approximate height of flood water (red arrow) against a still-closed Broadwater service station (top) and some of the many flood-deposited vehicles from over two weeks earlier.

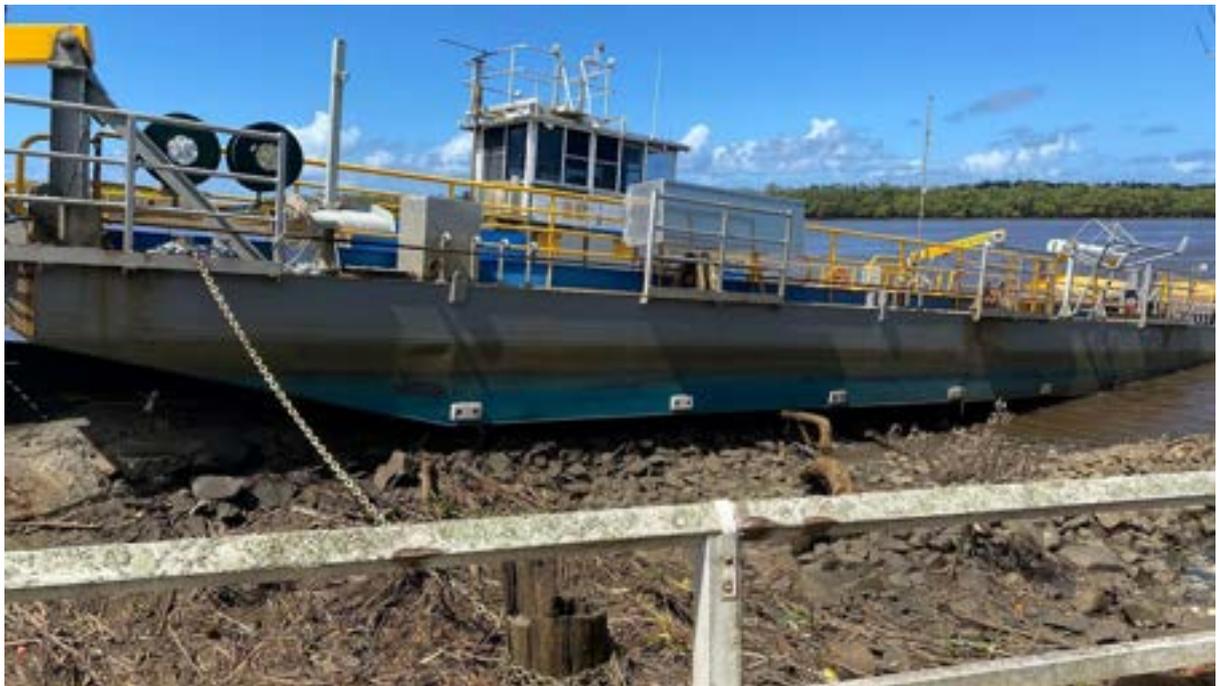
- Homes directly adjacent to the Richmond River showed signs of inundation, with water-damaged possessions on the footpath awaiting collection and clearly defined water level indicators on garden walls and garage doors of approximately 75cm.
- The Burns Point car ferry was still out of service (> two weeks later) following the flood. The ferry's primary submarine cable snapped in the high flow, causing the ferry to be pushed high on its entry driveway, causing damage to its hull (Figure 12). The ferry operators had prevented the ferry from being totally swept away by chaining the ferry to large, fixed pilings on the West Ballina disembarkation point. The ferry was still several days from resuming operation, awaiting a new cable from Brisbane which had been delayed due to the Brisbane floods, leaving the residents of Burns Point the burden of a 28 km round trip to travel to Ballina.

Figure 12: The Burns Point Ferry, stranded after its submarine cable snapped during the flood. Note the chain mooring the ferry to the piling on shore in the foreground, which prevented the total loss of the vessel

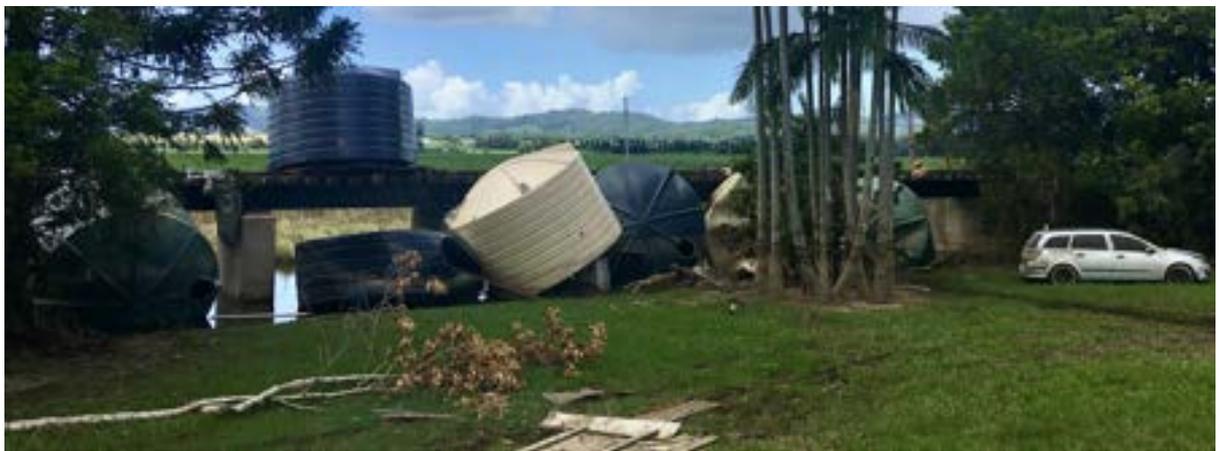
- permanent annexes and decking commonly contributes to severe damages occasioned by dwellings.
- South Murwillumbah provided the most notable example of the capacity of flood waters to transport plastic water tanks from farms and rural supply outlets and discard them across the landscape or beneath fixed objects, such as the railway bridge seen in Figure 14. There were numerous examples of destroyed water tanks lying in paddocks and along roadsides seen across the entire Northern Rivers region.

Figure 14: Plastic water tanks are easily transported by flood waters as seen in this example from South Murwillumbah where a number have been forced beneath a railway bridge.

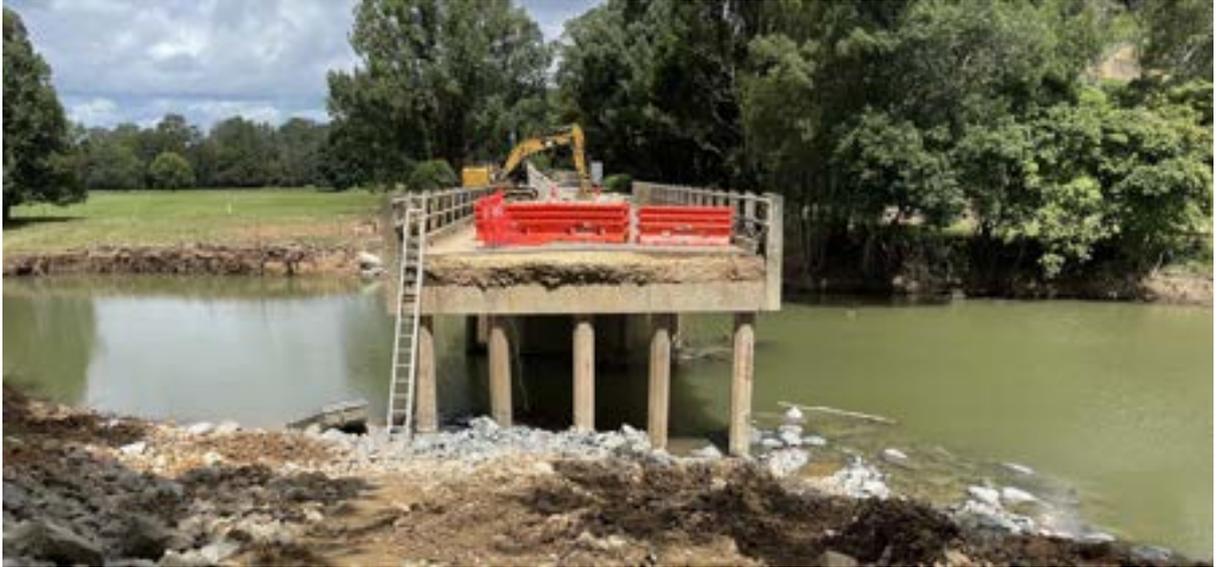
- Main Arm Road - the main route from Mullumbimby and Main Arm - remained closed after a large section of the bridge was washed away (Figure 15). Main Arm was isolated for three days following the flood.

Figure 15: The bridge on Main Arm Road between Mullumbimby and Main Arm, showing a large section washed away by the Brunswick River two weeks earlier.

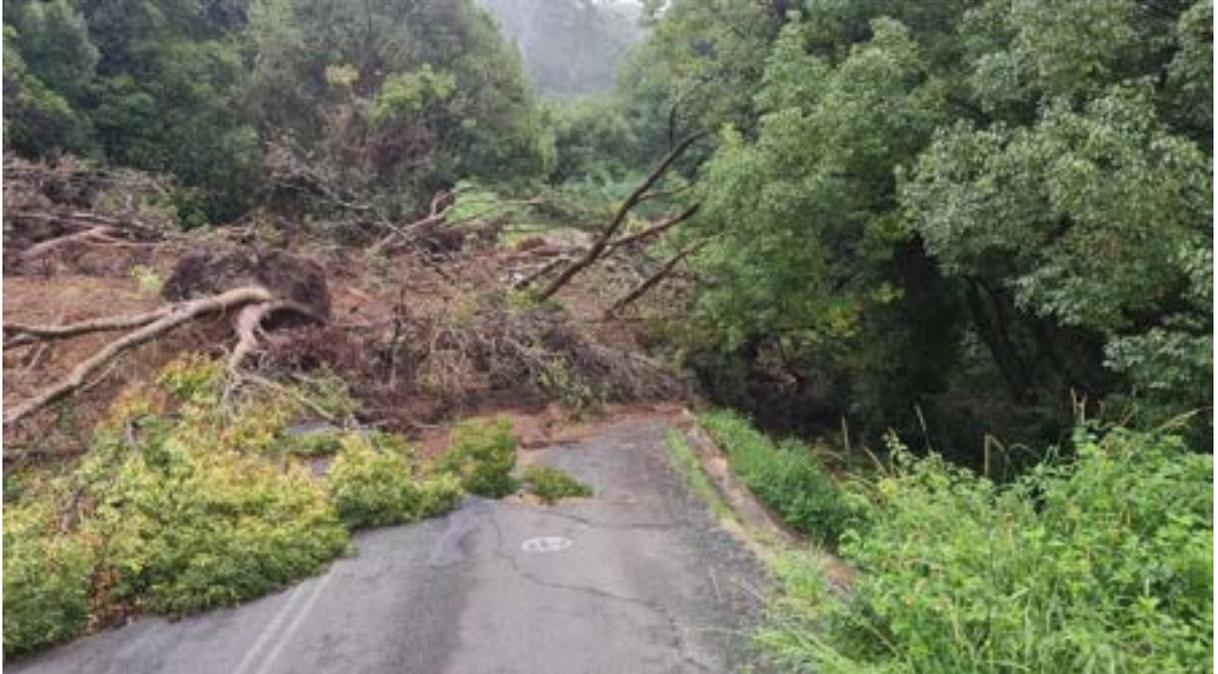
- Landslides - the Brunswick River catchment experienced numerous landslides. Some were even visible at long distances as scars on the surrounding hillsides - the result of a combination of the extreme rainfall, pre-saturated soils and steep terrain. Numerous local roads had been blocked as hillside debris collapsed onto road surfaces.
- In the neighbouring Wilsons Creek catchment (to the south), locals described large landslides, some still active with the sounds of cracking, being responsible for isolating properties which were being supplied with provisions by air drops (Figure 16).

Figure 16: A landslide in the Wilsons Creek catchment, south of Main Arm, completely blocking a road near Federal (Image source: Local resident known to survey team).

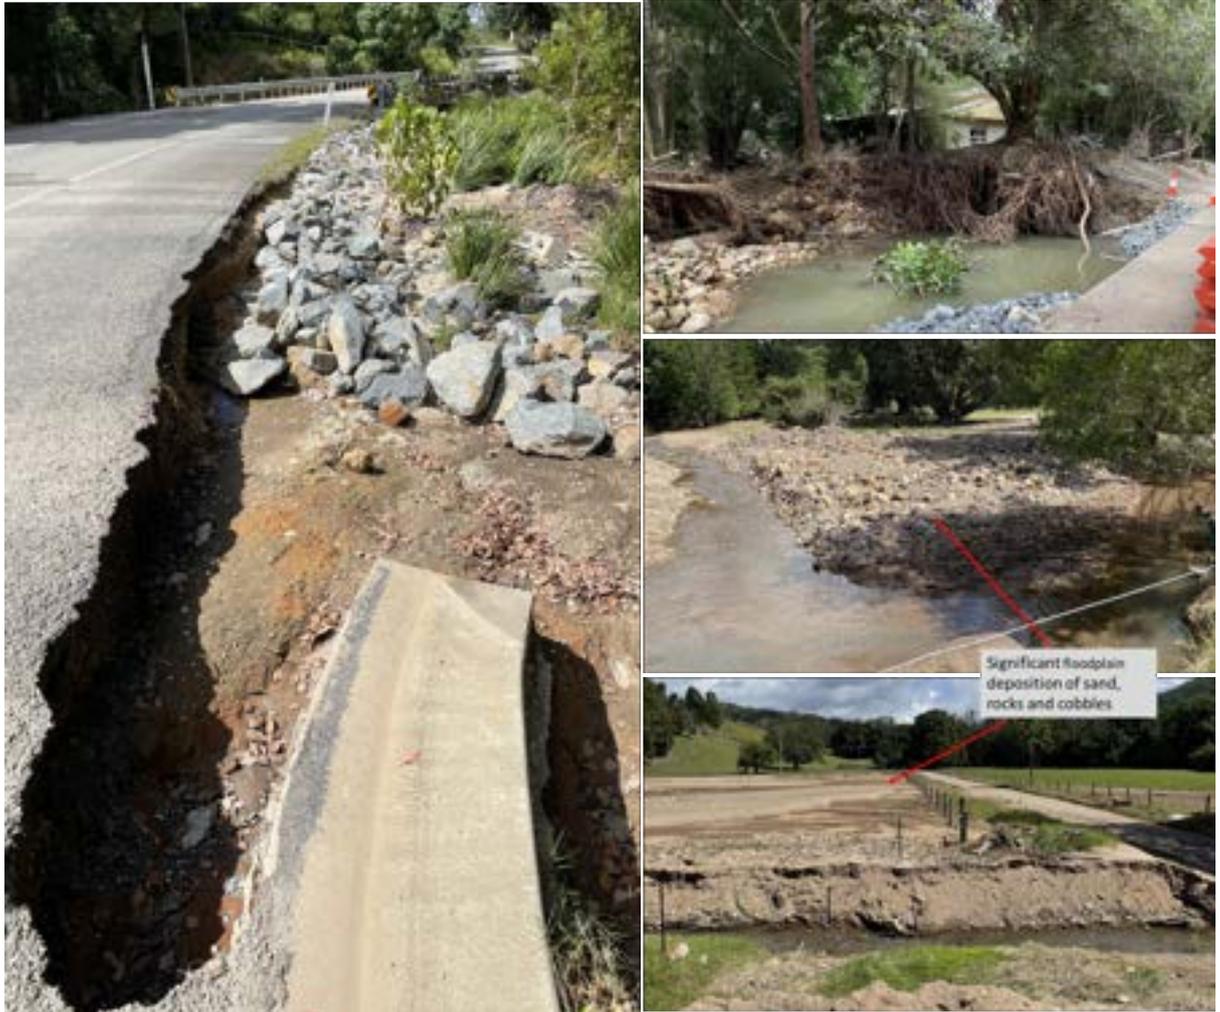
- The many causeways on Main Arm Road showed examples of torn up bitumen, eroded banks and exposed tree roots where soil had been stripped away by the force of flows (Figure 17). The valley floor provided numerous examples of deep and fast flowing flood waters having deposited large amounts of sediment - from sand to cobbles - over riverbanks, floodplains and across paddocks, roads and the grounds of Main Arm Public School, which remained closed. In places, sediment was in excess of 50 cm deep (Figure 17).

Figure 17: Road base and soil erosion from roadways and tree roots (left & top right) and evidence of fluvial geomorphic change with the deposition of sand, rocks and cobbles on floodplains (mid and bottom right) caused by deep and fast flowing flood waters in the confined Brunswick River catchment between Main Arm and Upper Main Arm.
