# **Flood Impact & Community Resilience Research, June 2025 [Part II]**

**Macleay and Hastings River Catchments** Between 19 and 25 May 2025, severe flooding occurred across the NSW Mid North Coast when an Easterly Trough Low (ETL) combined with warm, humid conditions to produce intense rainfall, gale-force winds, and major flooding. The event affected the Manning, Hastings, Macleay, and Nambucca catchments, leading to five confirmed fatalities, an estimated 10,000 homes damaged, 50,000 people evacuated, and widespread power outages and transport disruption (Figure 1).

This briefing note is Part Two of a two-part series, summarising Risk Frontiers’ flood impact and resilience field survey to the Mid-North coast conducted in June 2025. It focuses specifically on the Macleay River Catchment locations of Kempsey CBD, West Kempsey and Smithtown, and the Hastings River Catchment locations of Port Macquarie (Settlement Point Drive) and Wauchope. This research documents the impacts to housing, businesses, agriculture, and community recovery, while also summarising local experiences, lessons for resilience, and key challenges for managing future flood risk.

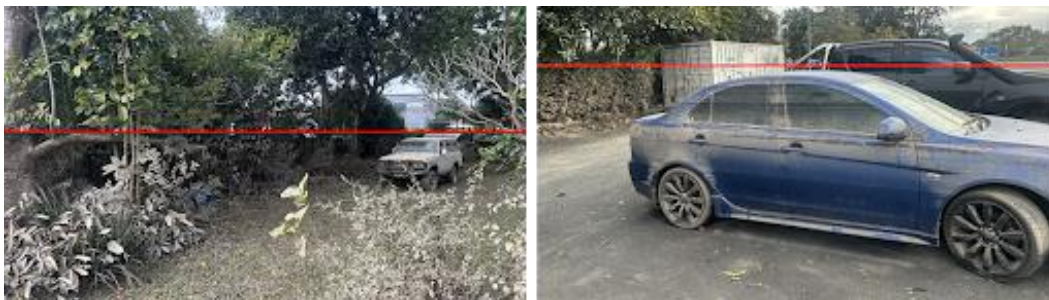
- An estimated 50 businesses in the Kempsey CBD were affected, many with extended closures and severe damage, with many reporting limited or delayed official warnings. Some parts of the CBD saw inundation up to nearly 2 metres (Figure 3)

**Figure 3.** Flood levels just below 2 metres in the Kempsey CBD from the flooded Macleay River catchment which peaked on Saturday 24th May

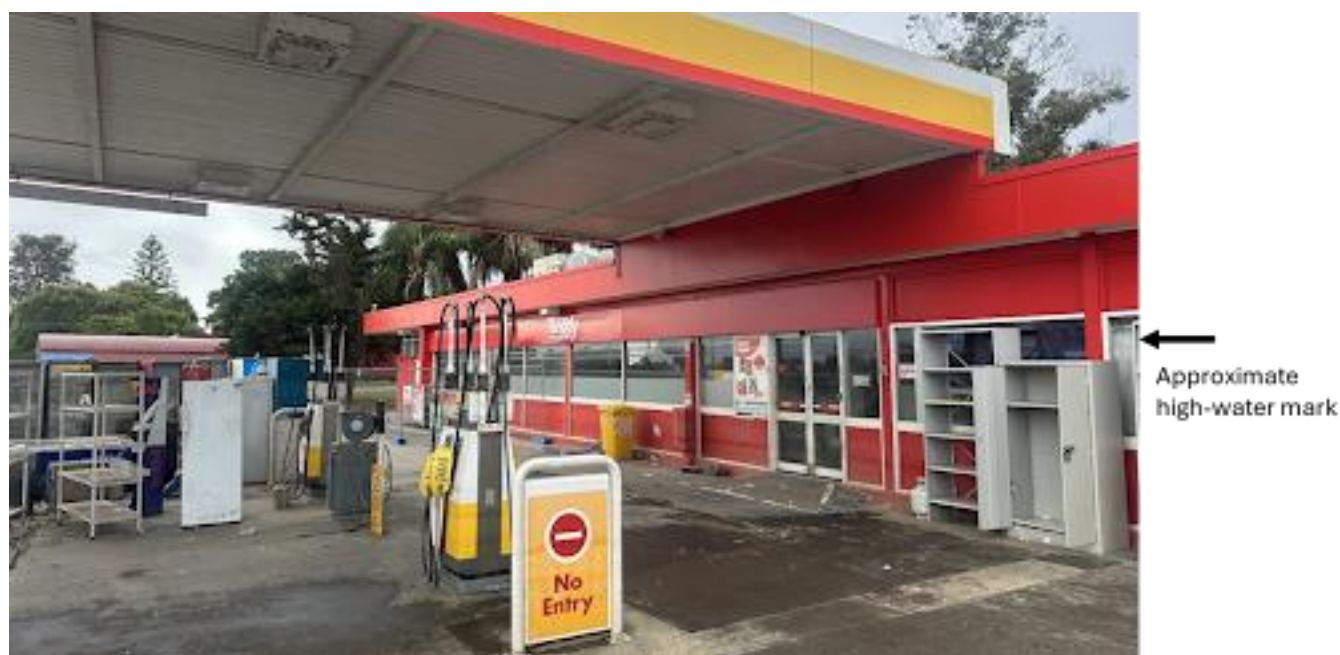
- Numerous businesses in the area remain closed due to extensive water damage. Many have not yet commenced clean-up or recovery efforts.
- An abandoned Shell Service Station (Figure 4) remains cordoned off, with damaged fridges and freezers placed outside, awaiting removal near fuel bowsers
- The shop interior has been completely stripped of all shelving and stock, indicating potential long-term closure.
- The motel next door to the service station was also severely inundated, with no signs of activity or management presence during the flood assessment
- Water levels in the area suggest the business has likely ceased operations indefinitely (Figure 4).

**Figure 4.** A service station in West Kempsey remains closed with the remnants of fuel bowsers, fridges and freezers destroyed in the flood behind tape. Flood level at this location was > 2 metre

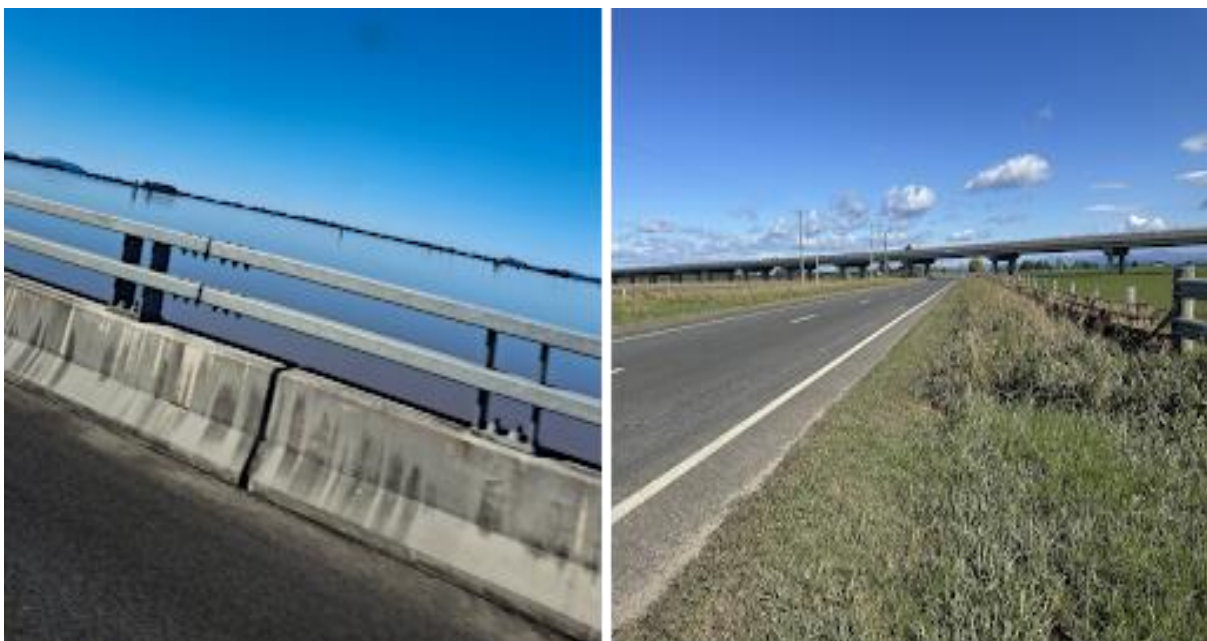
Extensive flooding across vast floodplains between Kempsey and the coast caused major road closures, cutting access to communities like South West Rocks, Hat Head, and the townships of Smithtown and Gladstone (Figure 5).

- Flooding in the Pola Creek area beneath the elevated Pacific Highway caused widespread property impacts. Many farmers are only now seeking help at recovery centres, having prioritised immediate clean-up
- Smithtown (Figure 2), on the Macleay River floodplain, was severely impacted with widespread property damage and significant inundation, much worse than Gladstone on the opposite bank due to Smithtown's lower elevation and exposure to overland flow

**Figure 5.** Pola Creek Area Between Kempsey and Smithtown: (Left image-taken by person known to survey team) – taken on 24 May from the elevated section of the Pacific Highway, shows the extensive flooding across the floodplain below, looking in the direction of Kempsey.(Right Image) – the same approximate captured on 4 June from the floodplain itself on South West Rocks road, beneath the Pacific Highway, during a site visit by the survey team.

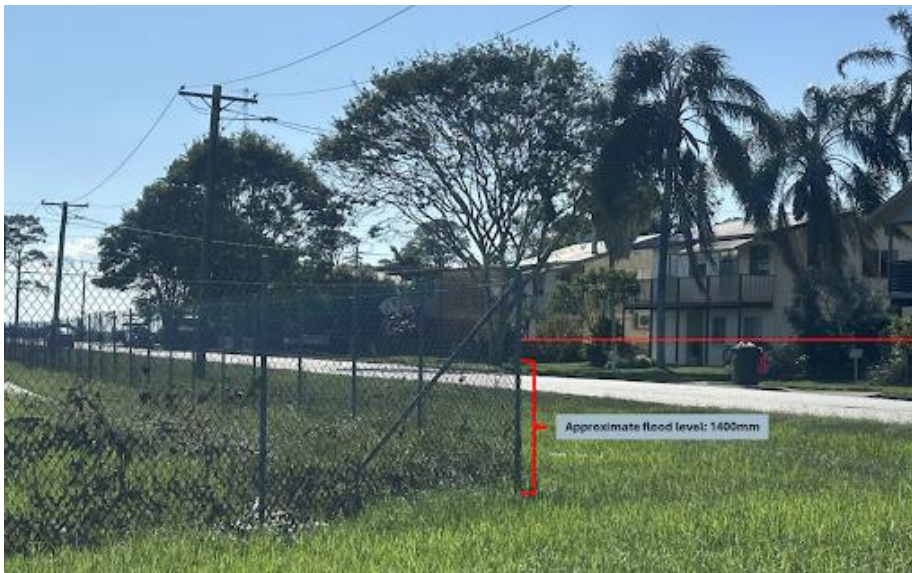
- Most Smithtown properties were affected, with some homes uninhabitable; Rawson Street saw floodwaters up to 1.4 metres deep (Figure 6), showing the extent of residential flooding
- Debris fields and sediment deposition across downstream paddocks show the high force and velocity of the floodwaters
- Gladstone, being slightly higher, avoided the worst impacts faced by Smithtown

**Figure 6.** Rawson Street at Smithtown showing abandoned homes and approximate flood height of 1400 mm (red line) determined from football field fence debris and flood water lines on homes

- Residents expressed frustration about river management and called for council dredging to reduce debris build-up and improve water quality during floods
- One resident with a home built to council-mandated elevation (one metre up) said it still wasn't enough to prevent damage in 2025
- Flood insurance remains costly but crucial in Smithtown; one homeowner noted that NRMA flood insurance was around \$29,000/year, highlighting the inaccessibility for many in high-risk areas.

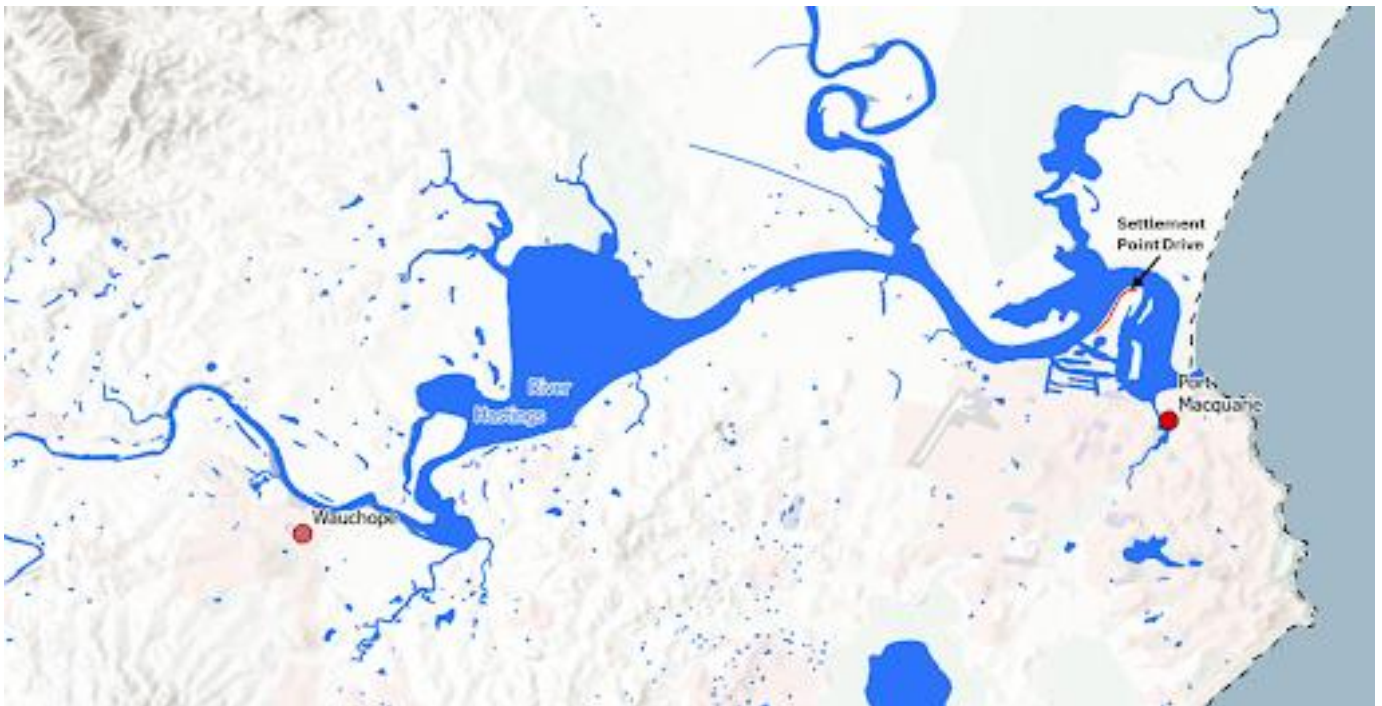
**Figure 7.** The Hastings River catchment including Wauchope and Port Macquarie (showing Settlement Point Drive)

The Hastings River catchment experienced significant flooding in 2025 due to intense and sustained rainfall across the Mid North Coast region of New South Wales (Figure 7). While the overall severity was less than the 2021 flood event, the impacts were still considerable across key locations, disrupting transport, inundating homes, and prompting evacuation warnings.

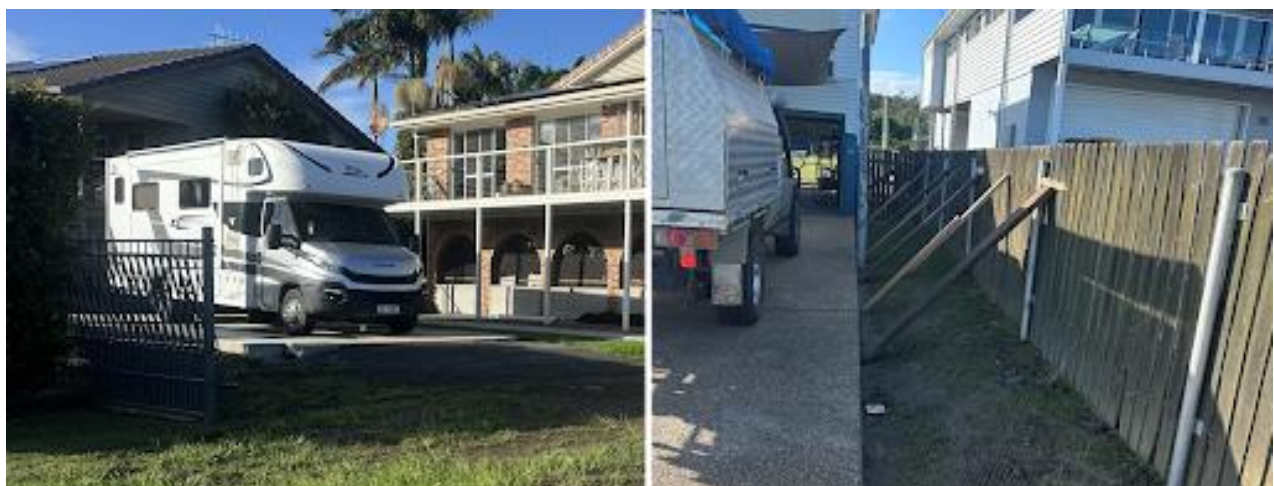
- Impacted residents said they learned from the 2021 event, now monitoring local flood indicators like river gauges and bridge levels to better anticipate impacts
- Many have made both temporary and permanent protective upgrades, such as elevated concrete slabs and stronger fencing with steel posts and timber bracing (Figures 8(a) and (b))
- The 2025 flood reflects a wider cultural shift toward individual preparedness and taking personal responsibility for managing flood risk in the local community.

**Figure 8.** Experience with flooding in 2021, these residents on Settlement Point Drive in Port Macquarie have increased their own personal resilience by making preparations to protect personal property. (Image on left) – shows a newly constructed elevated concrete slab and new motorhome which avoided inundation on this occasion. (Image on right) – after losing fences in 2021, this resident has reinforced fences with temporary timber bracing and galvanised steel poles with concrete footings (Image taken facing away from river)

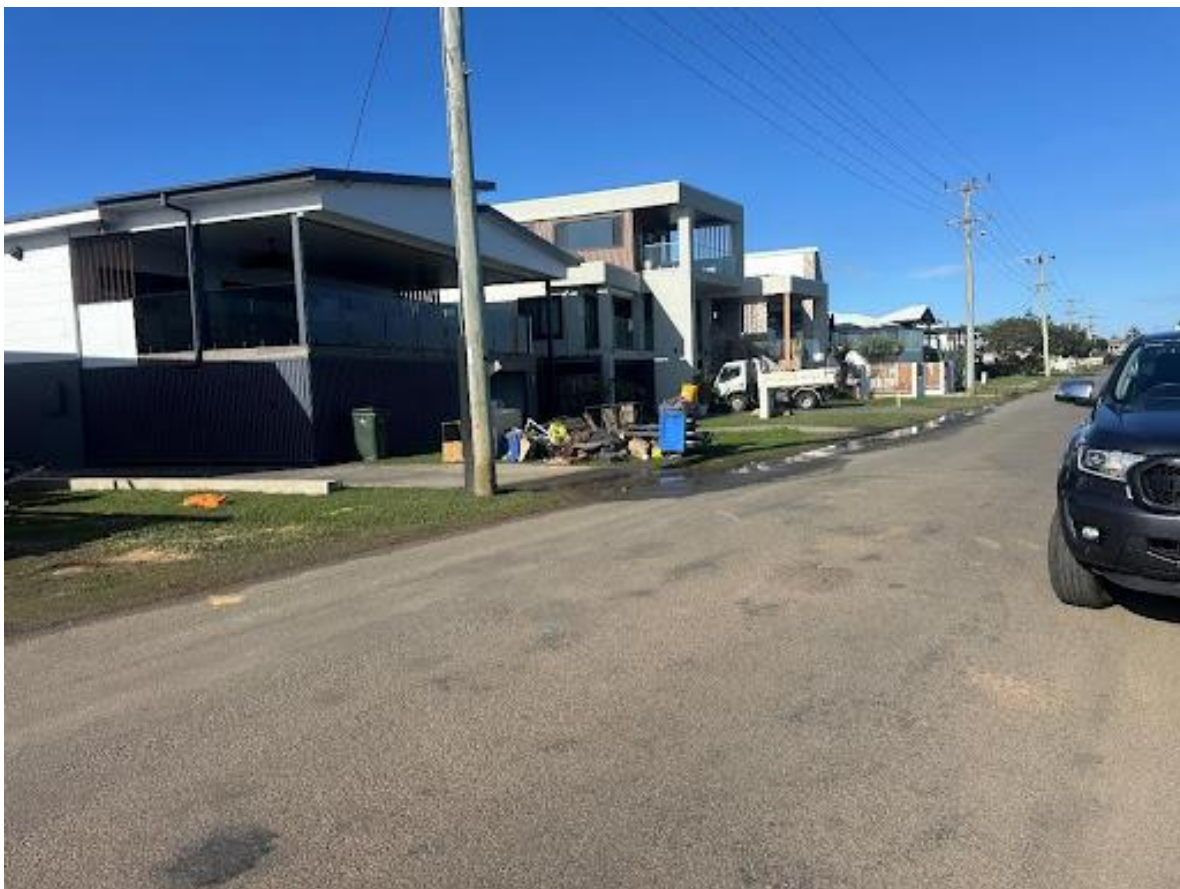
- One resident has consistently maintained flood insurance for nine years at around \$5,000 per year with Shannon's (underwritten by Suncorp). After major 2021 impacts, claims were filed promptly, with quick assessor response. Their house is concrete and raised, letting water pass through the garage level while living areas stay on the first floor (Figure 9)

**Figure 9.** One of only several houses on Settlement Point Drive Port Macquarie with flood insurance costing ~ \$5000 per year. Most houses on the street are raised on piers with living areas located on first floor and ground floor is largely a concrete shell / garage / storage which allows for waters to pass through

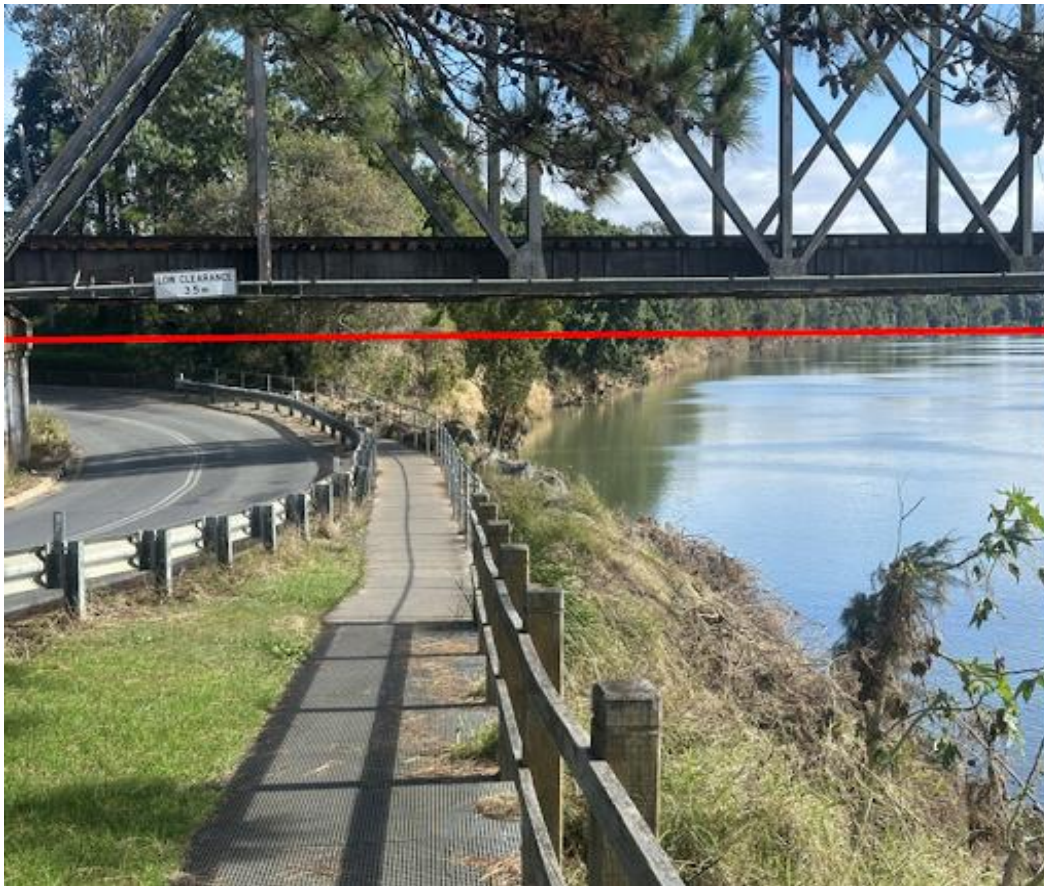
At the Wauchope Railway Bridge, the Hastings River rose well above the major flood level of 5.50 metres, reaching 6.82 metres and potentially approaching 7 metres at the peak of the event, as reported by Port Macquarie-Hastings Council (Figure 10). These levels significantly exceeded major flood thresholds and triggered emergency response measures

**Figure 10.** The Railway Bridge at Wauchope showing flood height (as approximated by local resident)

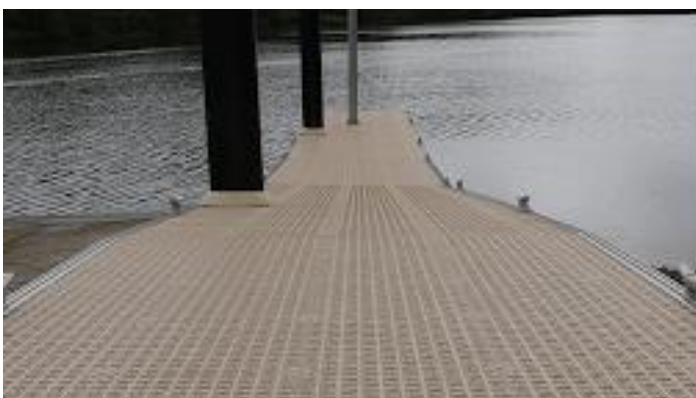
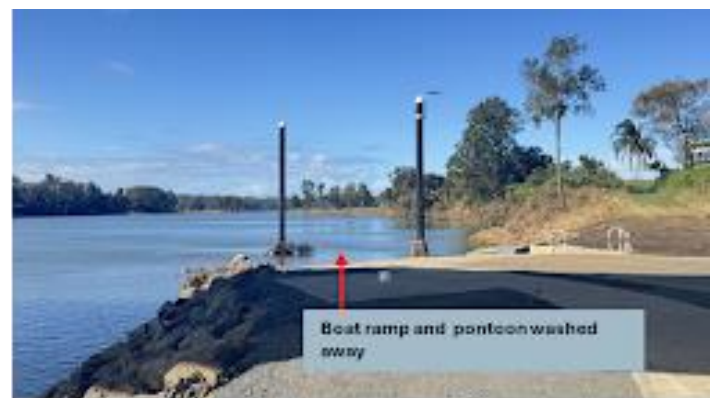
- The flood particularly impacted low-lying areas adjacent to the Hastings River also experienced inundation. Flooding led to widespread road closures throughout Wauchope and surrounding low-lying areas, restricting movement and emergency access. Additionally, infrastructure such as beach areas at a nearby boat ramp at Rocks Ferry reserve were affected by bank erosion and flood damage including the total removal of the boating pontoon and ramp (Figures 11 (a) and (b)).

**Figure 11.** From L-R, (L) the boat ramp and pontoon in situ at the Rocks Ferry reserve prior to the 2025 flood, and (R), the pontoon and ramp washed away
