## The Mw 7.8 November 14, 2016 Kaikoura Earthquake: Briefing 5.

This fifth briefing contains observations arising from a visit to Wellington and Blenheim (Dec. 5 – 12, 2016)

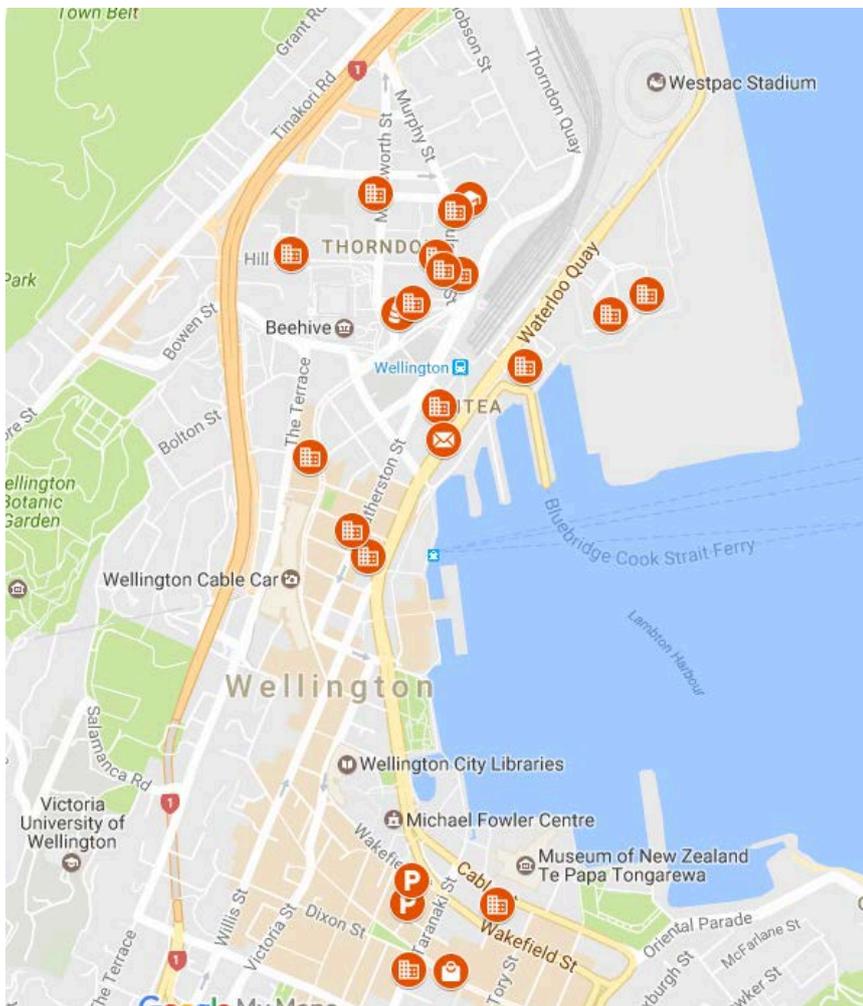
At the time of the visit about 40 buildings, most of which were formerly occupied by Government departments, had been evacuated. Most but not all of these are located on reclaimed land near the Port and Quays (Figure 1). These evacuations were thought to be mostly precautionary and awaiting more detailed engineering reports or because of non-structural damage such as the failure of roof panels, plumbing and electrical services. As a result about 10% of Wellington’s public servants are currently working offsite. Three buildings – 61 Molesworth Street, Statistics House and the Reading Cinema car park – are badly damaged.

**Figure 1:** Locations of buildings with or suspected of experiencing damage. (<http://www.stuff.co.nz/national/nz-earthquake/86510017/questions-asked-in-capital-but-engineers-say-no-such-thing-as-earthquakeproof>).
