22 February 2011 Lyttelton earthquake, Briefing 3

Matthew Mason and Paul Somerville

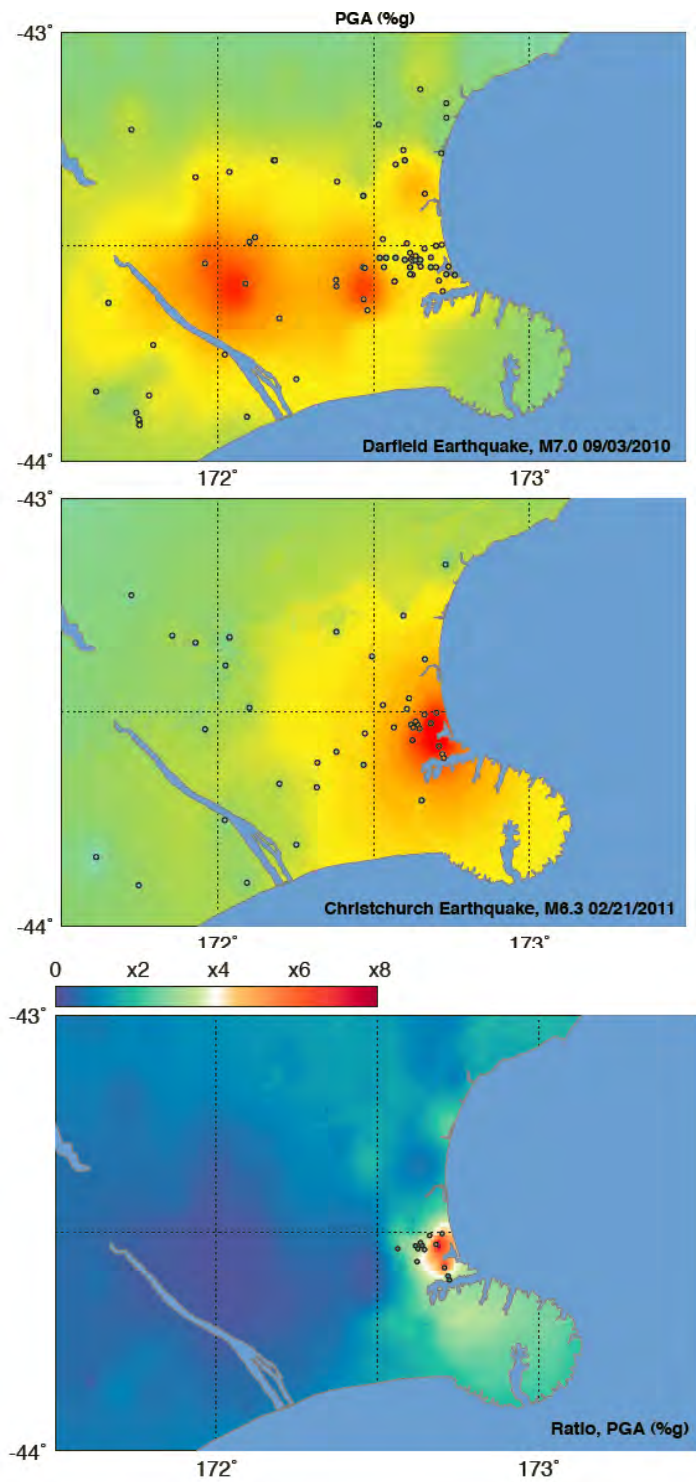
Figure 1 shows interpolated peak ground acceleration surfaces for the 2010 and 2011 earthquakes. Although the Darfield event had a higher magnitude, the focal area of high accelerations was well west of the CBD and much of the city's housing stock. In contrast, during the 2011 earthquake the area of greatest accelerations was directly under the city and its southern suburbs. Peak ground accelerations up to 8 times larger than those experienced during the 2010 event (lower image) were felt in densely populated areas of the city.

Figure 1. Comparison of peak ground accelerations for the two Christchurch earthquakes. The top panel is the 2010 Darfield (Canterbury Plain) earthquake, the centre panel is the 2011 Christchurch (Lyttelton) earthquake, and the bottom panel is the ratio of peak acceleration (Christchurch/Darfield). Source: David Wald, personal communication.

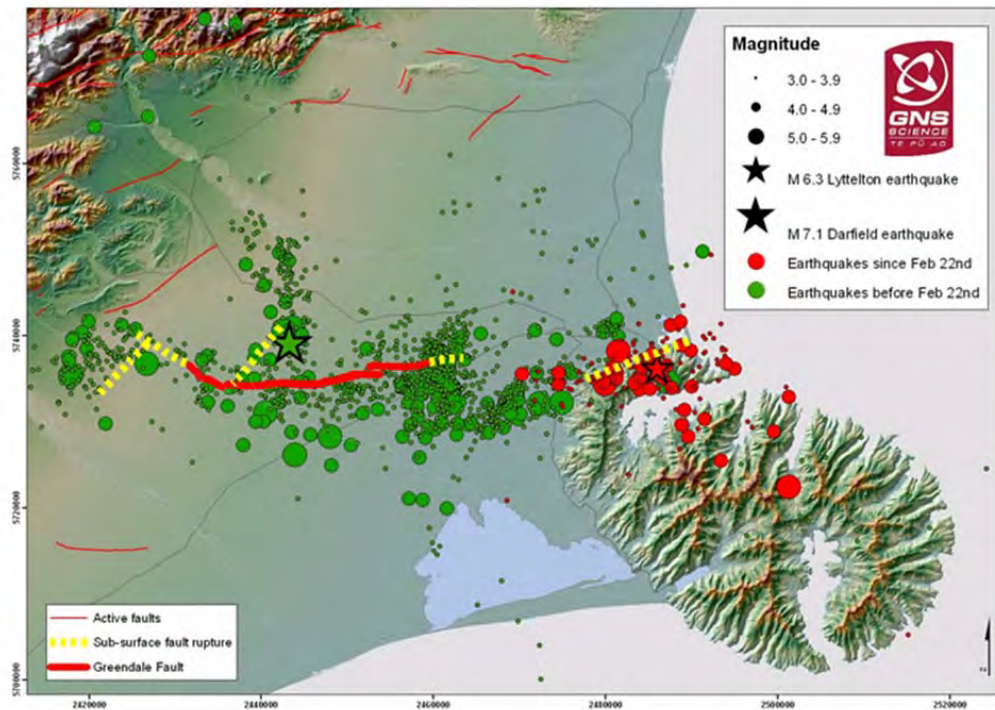
At present, the orientation of the fault that caused the earthquake is not well known. GNS Science (Figure 11) infer that the earthquake may have occurred on the dashed yellow line striking east-northeast just south of Christchurch, based on aftershocks, not on any mapped fault or surface feature. The global seismic moment tensor solutions by Harvard and the USGS both show that one of the fault planes may have been a plane dipping down to the southeast at about 57 degrees on a plane striking northeast, perhaps consistent with the dashed yellow line in the map but striking more northeast. If that is the case, then the rupture began at a depth of about 10 km southeast of Christchurch and propagated updip and to the northwest directly toward Christchurch, causing a strong pulse of ground motion due to rupture directivity effects. The rupture directivity pulse recorded at Lyttelton (LPCC) is shown in the top panel of Figure 12. Lyttelton is located on Tertiary volcanic rock (Figure 13).

Figure 11. Map of surface faulting (red line) observed in the September 4 2010 event, and subsurface faulting inferred in the same event (western four segments) and the February 22 2011 event (eastern segment). Source: GNS Science.

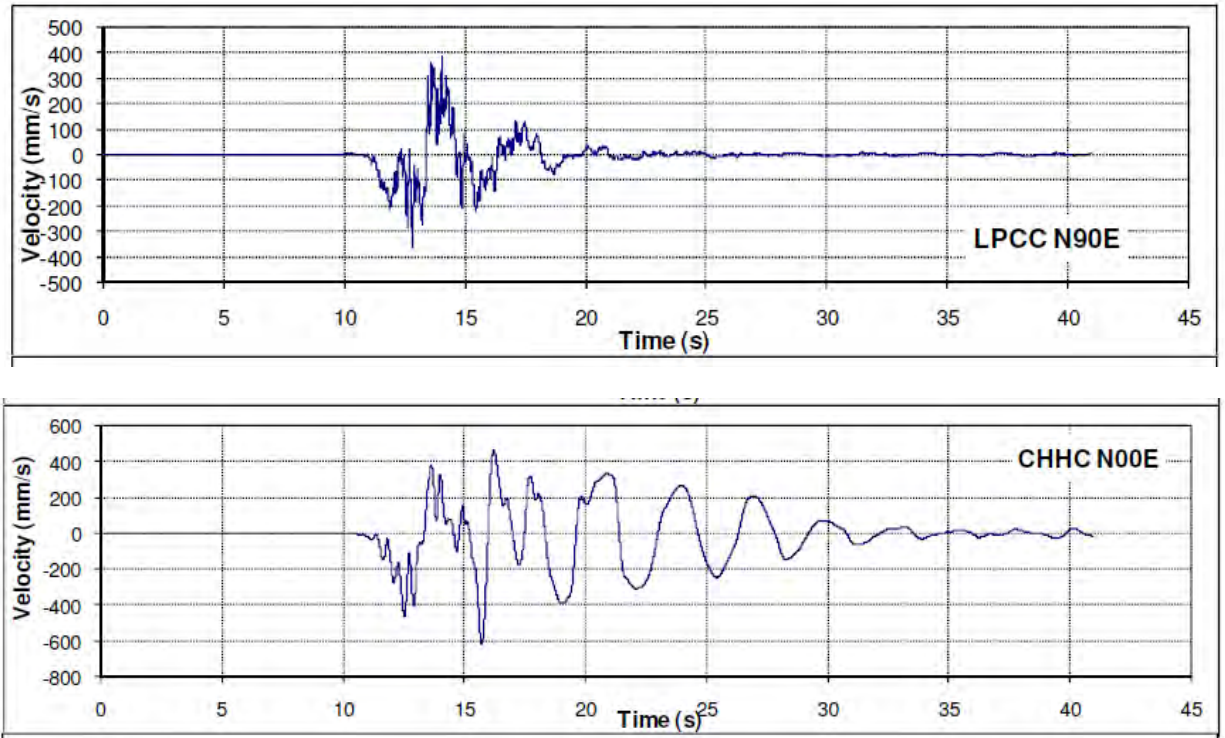
The three-dimensional structure of Christchurch may have caused localised amplification of the ground motions in Christchurch, which is located on a sedimentary basin (Figure 13). The seismic body waves from the earthquake entered the basin through its thickening edge, becoming trapped within the basin and generating a long train of surface waves. These surface waves are seen following the rupture directivity pulse in the recording at Christchurch Hospital, shown in the bottom panel of Figure 12.

Figure 12. Ground velocity recorded at Lyttelton (LPCC, top) and Christchurch Hospital (CHHC, bottom). The Lyttelton record shows a brief but strong rupture directivity pulse, while the Christchurch record shows that pulse followed by surface waves generated at the basin edge. The records were processed by John Zhao of GNS.

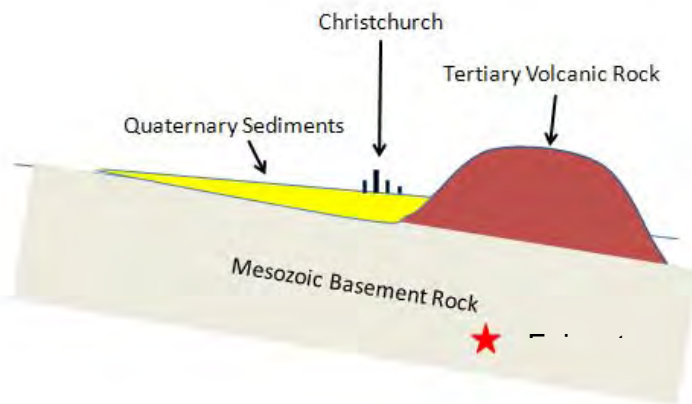
Figure 13. Schematic North – South geological cross section of Christchurch. Source: George Walker
